Road Safety Audit Stage 1

B3078 Cycle Link Scheme

Fordingbridge

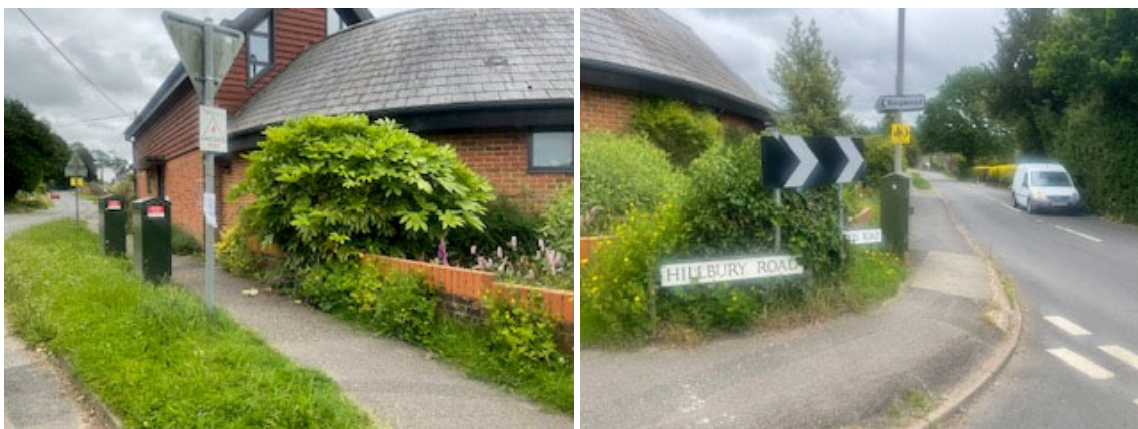
Location: Hillbury Road junction with the B3078.

Summary: Reduced visibility could lead to sudden braking and rear end shunts or vehicle to pedestrian collisions.

A crossing point is proposed across Hillbury Road, however, intervisibility at the crossing point is restricted due to utility cabinets and vegetation – see figures 2 and 3 below. Reduced visibility could lead to sudden braking and rear end shunts or vehicle to pedestrian collisions.

Figures 3&4: Obstructions to visibility at the proposed crossing point.

It is recommended that pedestrian and vehicle intervisibility splays should be unobstructed and maintained.
