STRUCTURAL REPORT

Anchor Paddock
Batchelors Lane
Wimborne
BH21 7DS

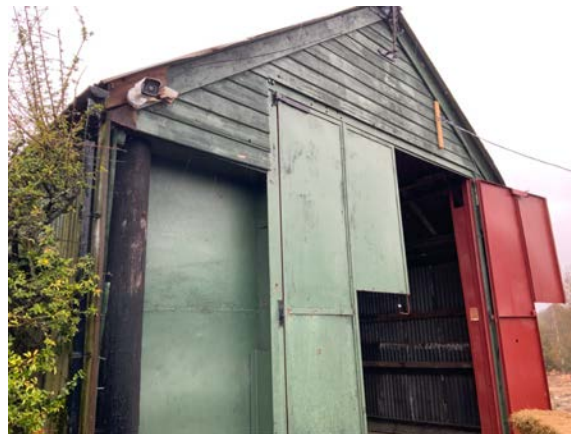
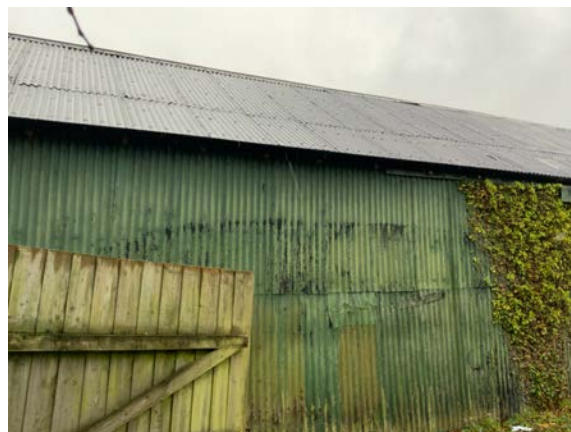
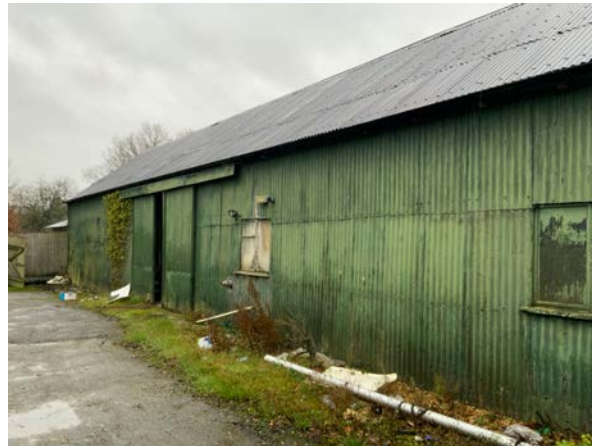
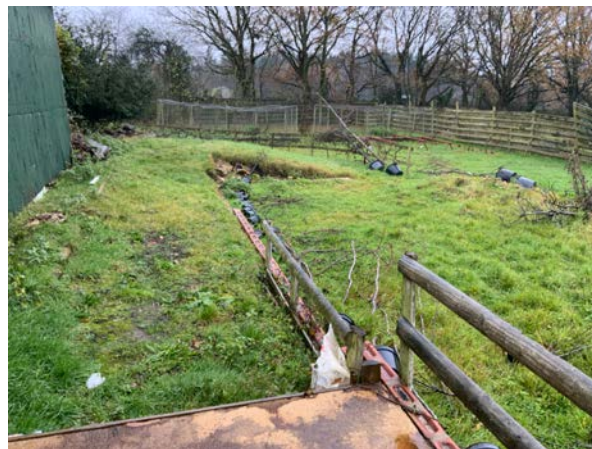
Exterior photos

The external walls and frame of the property were found to be vertically upright and sound with no sign of significant movement in the floor slab or roof structure.

The concrete floor slab was also sound, where visible, and the roof showed no sign of sagging.

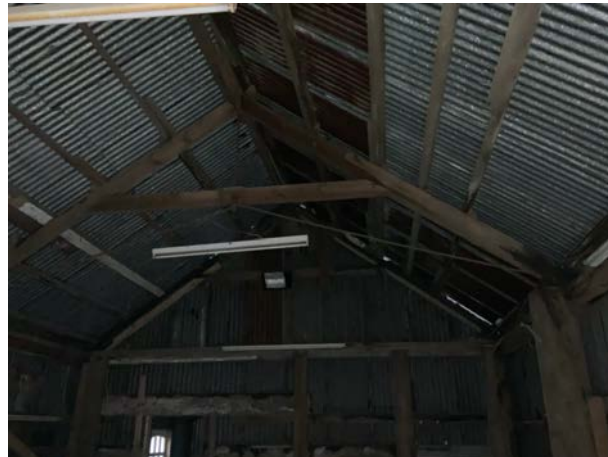
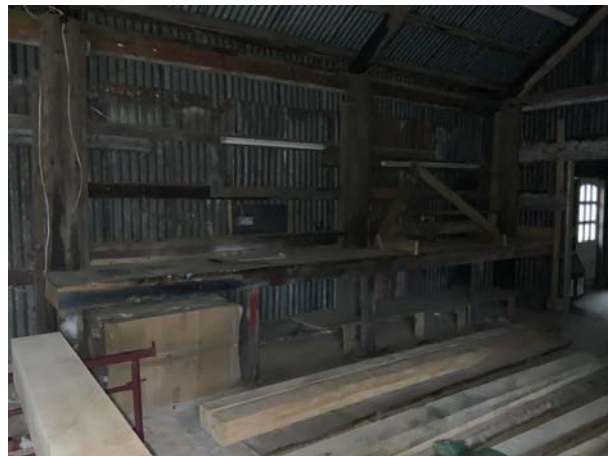
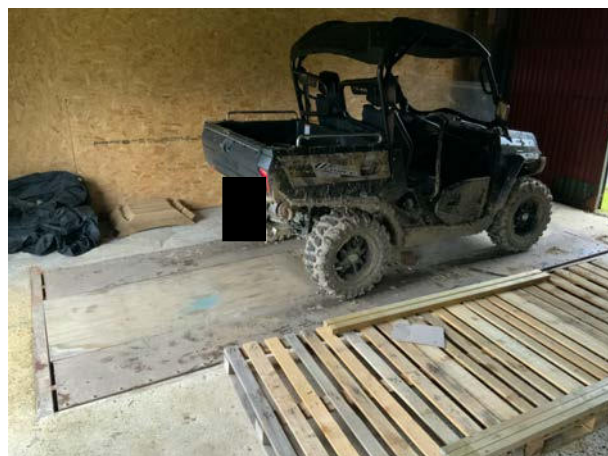
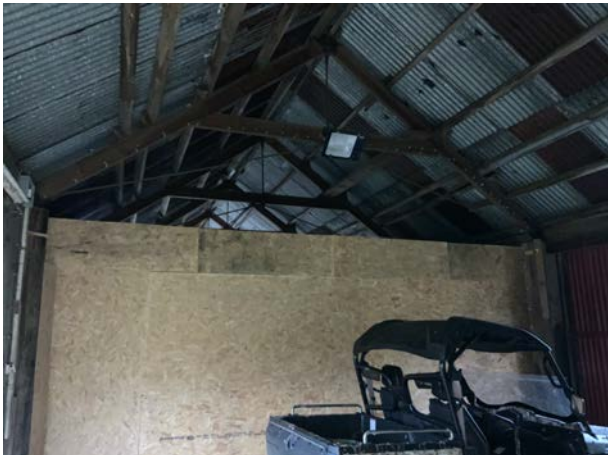
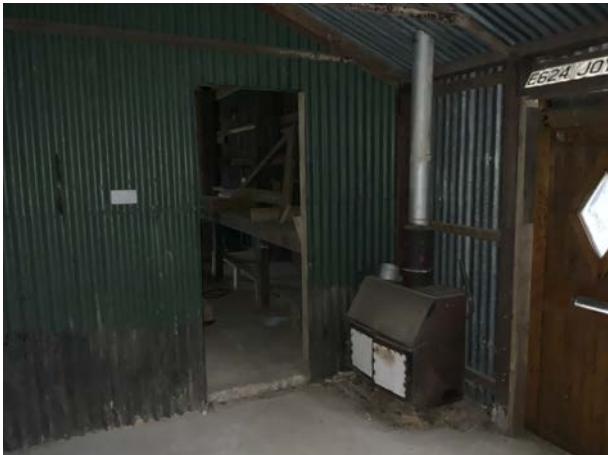
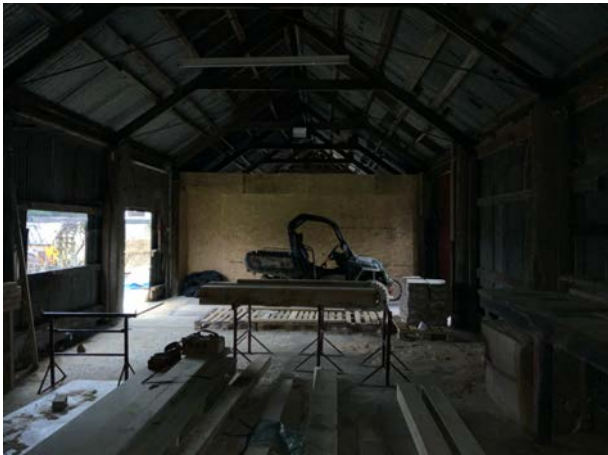
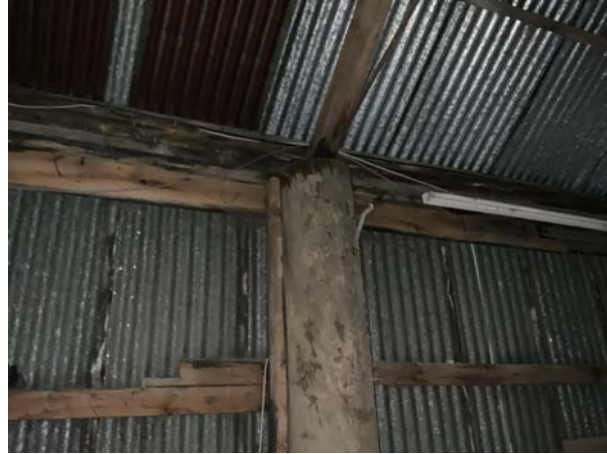
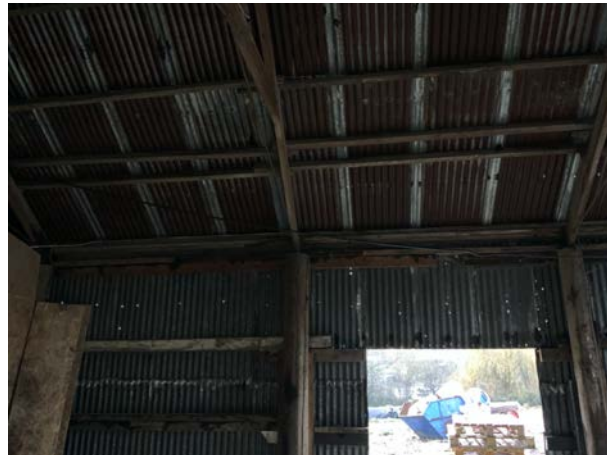
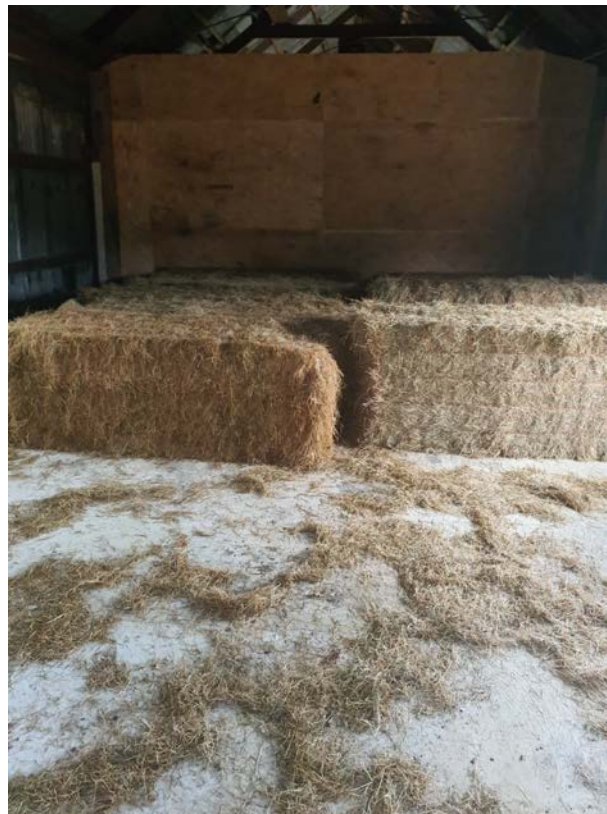
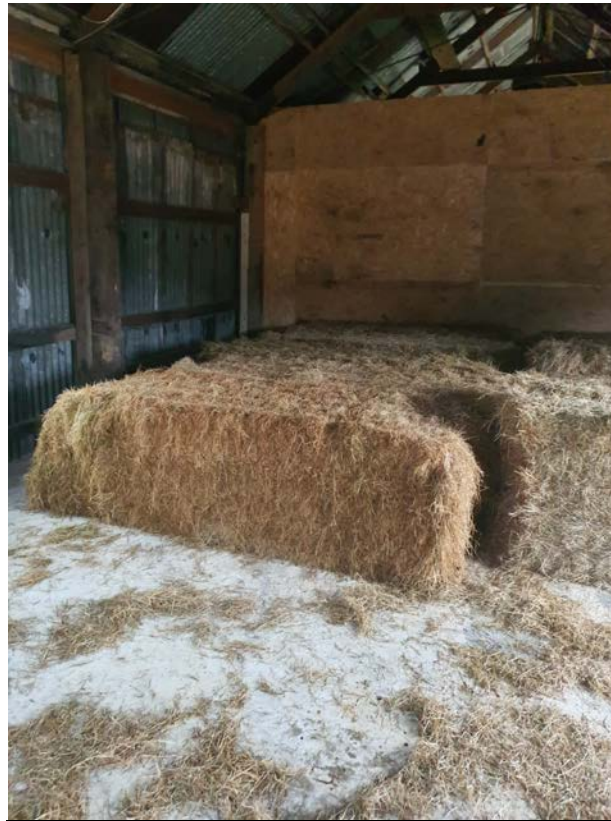
Interior photos

The structure was found to be in good condition and is considered to be suitable for conversion, without the need for additional structural elements.
