East Creech Conservation Area Appraisal

Adopted document February 2018

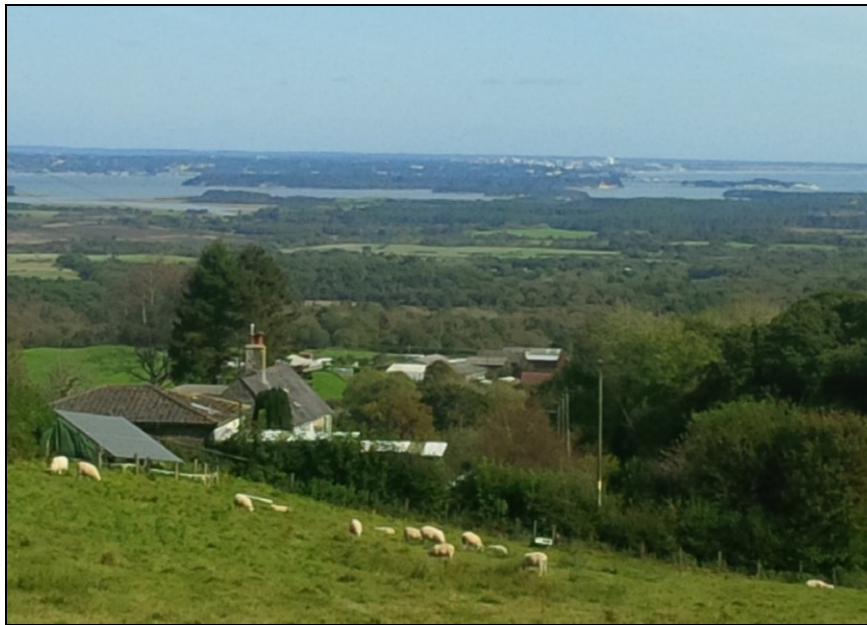
FIG. 1: *View to the east. As the land rises, Poole Harbour, Brownsea Island and the settlements beyond dominate the view. The foreground is compromised by modern structures at East Creech Farm and Creech Barrow Cottage where sheet roofing materials are conspicuous. It is surprising that no past attempt has been made at camouflage.*

74. Views into the conservation area from higher ground to the north west, west and south west are not however wholly positive (see FIG. 1). These are dominated by the bulky modern agricultural buildings to the rear of East Creech Farm and flat roofed ancillary structures at Creech Barrow Cottage. These compromise rather than lend interest to the broad landscape panorama.

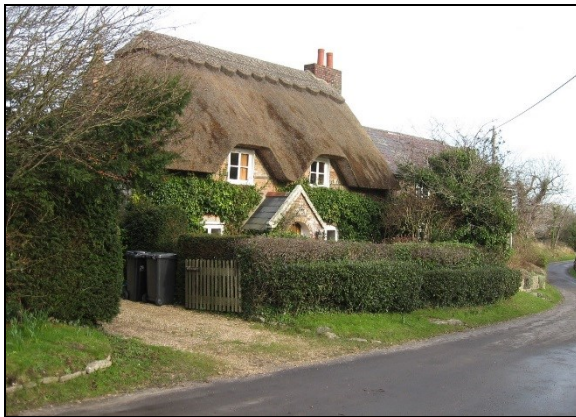
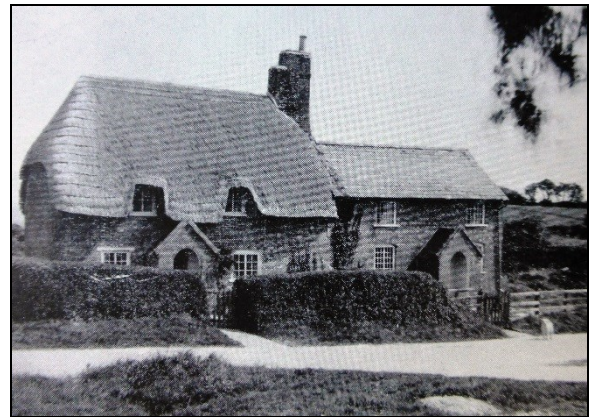
FIG. 2: *Rockley Cottage. One of the oldest cottages in the hamlet. Dramatic changes in the appearance of the roof have arisen from replacement of the historic covering as seen by comparing a modern view with one included in the RCHM survey of 1970. The block ridge is a modern feature not typical of the local tradition.*

20. Rockley Cottage (FIG. 2 below) and the western range of East Creech Farmhouse (see cover) have been dated to the seventeenth century. A further cottage of seventeenth century origin (described by the 1970 RCHM survey) stood to the front of Wren Cottage as late as the 1960s, though had been demolished by the 1980s.

45. Some of the cottages within the conservation area were originally constructed using cob. Use shows a clear differentiation in the status of construction relative to the contemporary western range of East Creech Farm, which was constructed in stone (see cover photo). The clay content of the surrounding soils combined with the ready availability of chalk is particularly favourable for cob construction. Rendered cob remains visible at Wren Cottage (see FIG. 10), where use apparently post-dates the brickworks, though at Rockley (see FIG. 2) the walls have been faced in brick.

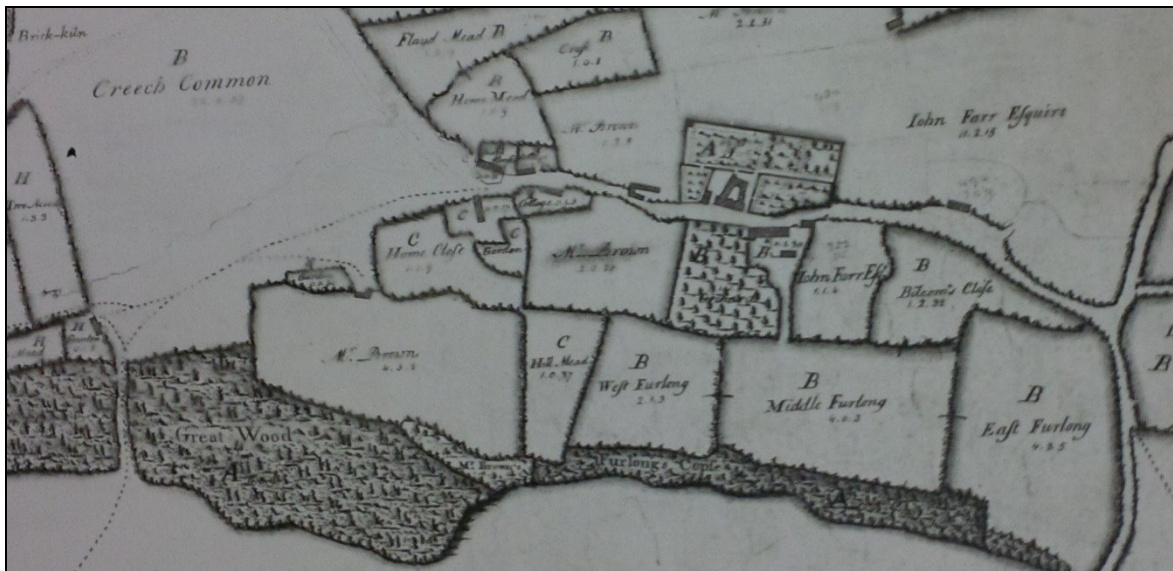
FIG. 3: Excerpt from John Sparrow’s 1768 Map. Note the plan form and enclosed gardens of East Creech Farm. Other buildings shown include Rockley and Keeper’s Cottage. The ‘brick kiln’ is labelled in the top left hand corner on the edge of Creech Common. Courtesy of Dorset History Centre (Photocopy 16).

23. The 1768 map (see FIG. 3 above) provides evidence of early industrialisation with a brick kiln shown to the north of Keepers Cottage at the edge of what was then common land. FIG. 9 shows the brickworks as it existed in 1888.

65. The 1768 map of the manor (see FIG. 3) shows a large orchard opposite East Creech Farmhouse and further orchards in the walled gardens enclosing it. These orchards do not appear to have survived the nineteenth century, though the semi-domestic character of the open space opposite the farmhouse seems to reflect its former presence. More recently a small orchard has been established adjacent to Rockley.
66. Agricultural land around the hamlet provides a largely open setting for the buildings within it. Openness is accentuated in places by transparent boundary treatments (e.g. post and wire or post and rail fencing). This is most noticeable travelling towards the hamlet from Creech Barrow Hill across the old common (see FIG. 13 below), and is also a feature south of the duck pond (see FIG. 14 below).

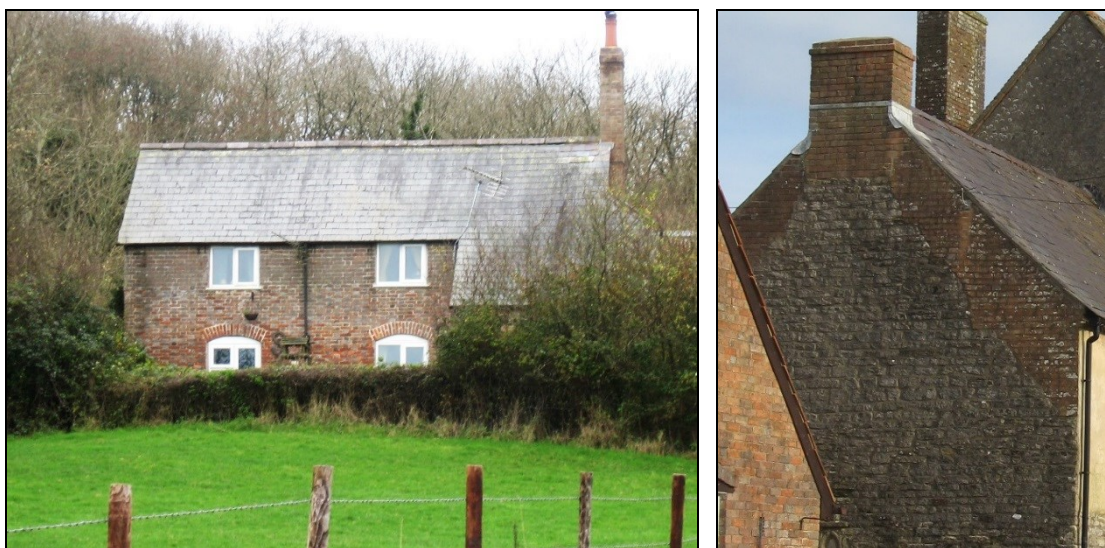
FIG. 5: *Increases in height. Both Keeper's Cottage (left) and the west side of East Creech Farm (right) show signs of a historic increase in height. At Keeper's Cottage the band of brickwork at first floor level is a different colour to that below, whilst brick has similarly been added above stone at the farmhouse. Each carries a slate roof though given the age of the buildings the original coverings would have been different. Keeper's Cottage may have originally been a single storey thatched dwelling.*

37. Several buildings show external evidence for historic increases in height. In residential buildings this is typically associated with historic addition or enlargement of upper storeys (see FIG. 5). This is suggested by changes in construction visible on the west gable of East Creech Farmhouse, front elevations of Keeper's Cottage and Jubilee Cottage and in the western half of Fuchsia Cottage. Buildings which appear to remain at their original height include the diminutive Little Cottage, whose low one and a half storey form remains discernible despite being encircled by modern extensions, and the core of Wren Cottage (see FIGs. 10 and 16).

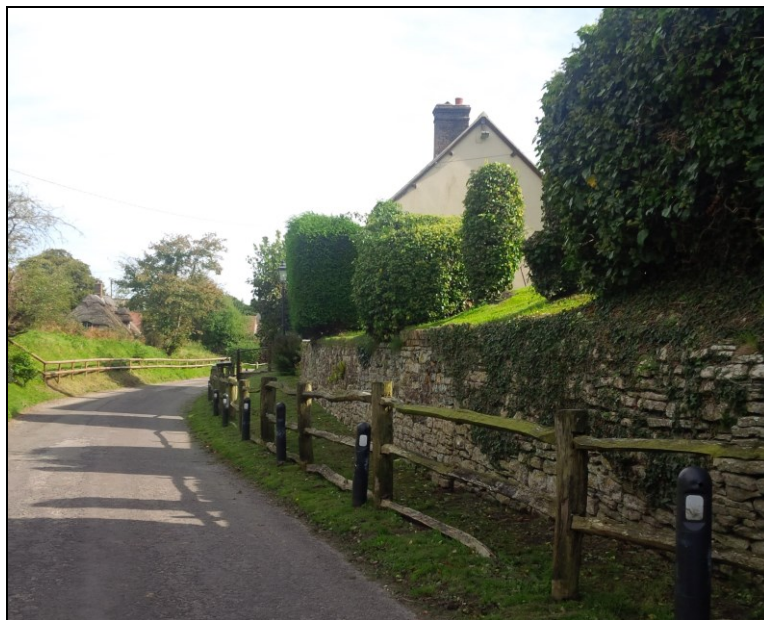
FIG. 6: Means of enclosure. Split post and rail fencing is a feature of the west half of the hamlet. Where used in conjunction with other boundary treatments it can sometimes create clutter. The view above shows the stone retaining wall and verge at the front of Fuchsia Cottage along which reflective bollards are also positioned.

42. Split post and rail fencing frequent, though its current use in the west half of the settlement often appears ornamental. Where this has been introduced forward of, or on top of a pre-existing boundary treatment this introduces an element of clutter to the view.

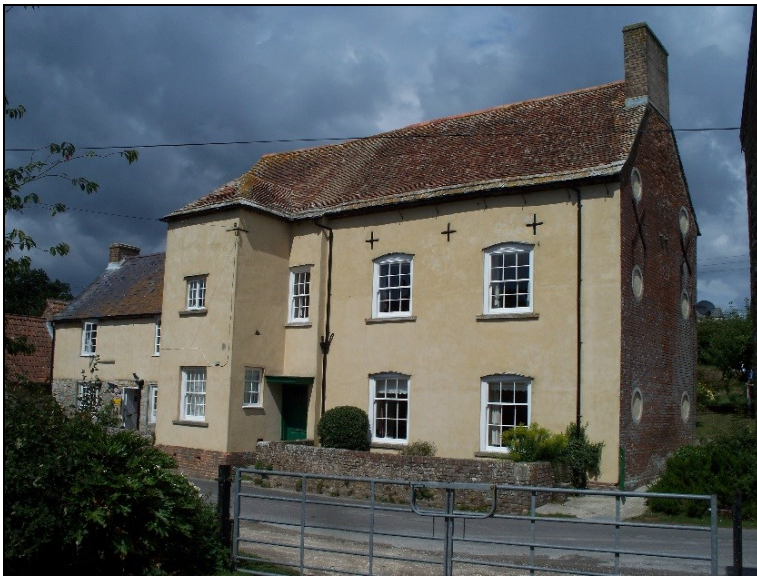
FIG. 7: *East Creech Farmhouse. The west half of the building (also see cover photo) dates to the seventeenth century and has been increased in height, whilst the east range appears to have been more substantially remodelled during the eighteenth century. The two storey porch is an interesting feature.*

52. East Creech Farm sees combination of plain clay tiles with an easing course of stone tiles at the eaves (see FIG. 7 and cover). This style of roofing appears to have been a popular around the District during the late eighteenth century, most typically for larger houses. The use of stone tiles at the eaves helped to shed rainwater clear of the eaves in the absence of gutters. Prior to its unsympathetic conversion, a more unusual combination of Welsh slate with stone tiles was a feature of the small agricultural building east of the barn (see FIG. 11 below). As this building is shown in the map of 1768 it seems probable that slate itself was not the original covering.

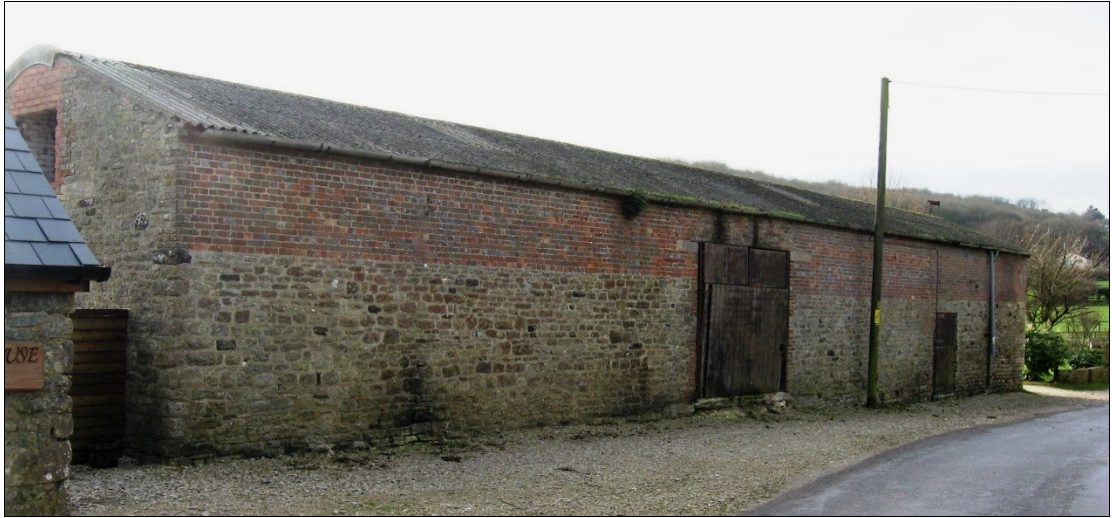
FIG. 8: Stonework. *The barn opposite East Creech Farm features a mixture of limestone and heathstone rubble. The walls have been raised or modified in brick. The building was heavily altered during the twentieth century and is compromised by the sheet roof and poorly formed entrance which was previously arched.*

- *Agricultural buildings opposite East Creech Farm* (FIG. 8): these historic buildings are not specifically listed, though have a major presence within the conservation area. Sadly the smallest of the group has already been subject to an insensitive conversion that has caused loss of the historic fabric and details shown in FIG. 8. Scope remains for sensitive works to the barn that could include the reinstatement of lost features, particularly to the main entrance and roof, enhancing the contribution the building makes to the conservation area.

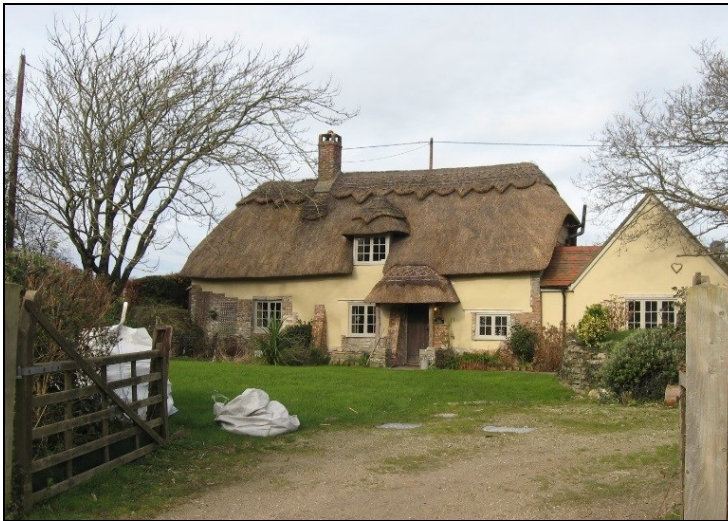
FIG. 10: *Wren Cottage. The original part of the structure stands at the centre. The elaborate block ridge is not a traditional feature.*

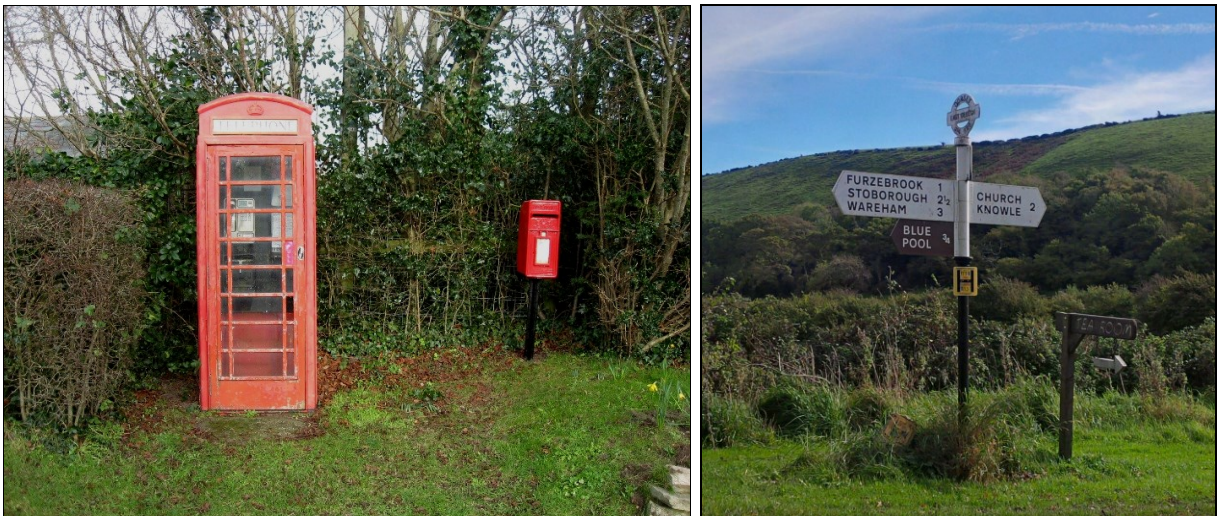
FIG. 12: Street furniture. Left: red telephone kiosk adjacent to Rockley. Right: finger post at the east end of the hamlet.

60. The conservation area contains a red K6 telephone kiosk adjacent to which is positioned a square topped Royal Mail post box (FIG. 12 below). The telephone kiosk is a 'jubilee' model (date range 1935-52), identified by use of the Tudor crown. It appears little used, the interior filled with cobwebs. Externally the paintwork is in poor condition. The post box is post-1952 date.
61. A traditional finger post stands at the Furzebrook Road junction at the east end of the hamlet (FIG. 12 below). This retains its distinctive roundel. The finger post has clearly been refurbished, and whilst in good condition, has lost its original cast lettering.

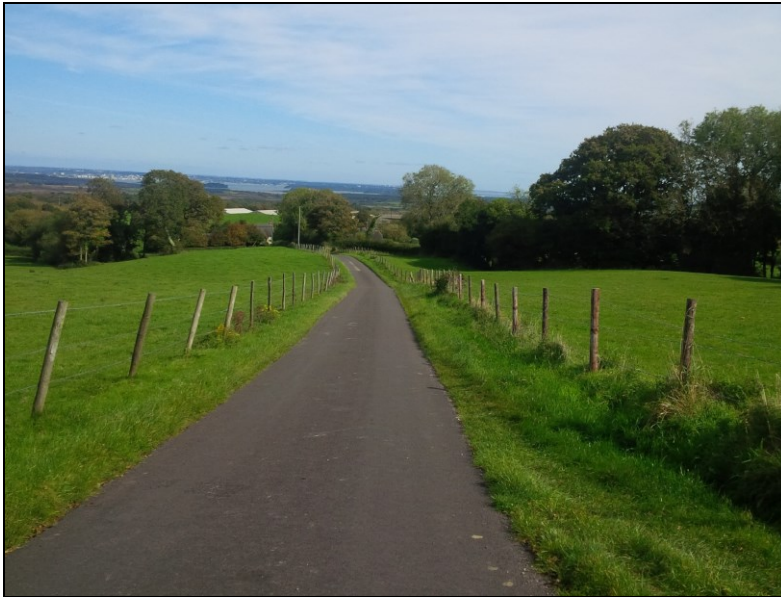
FIG. 13: *The old common. A sense of openness remains despite the fencing. The road here was only formalised during the twentieth century, and was previously a track which meandered across the common. Woodland helps to define and shape the space.*

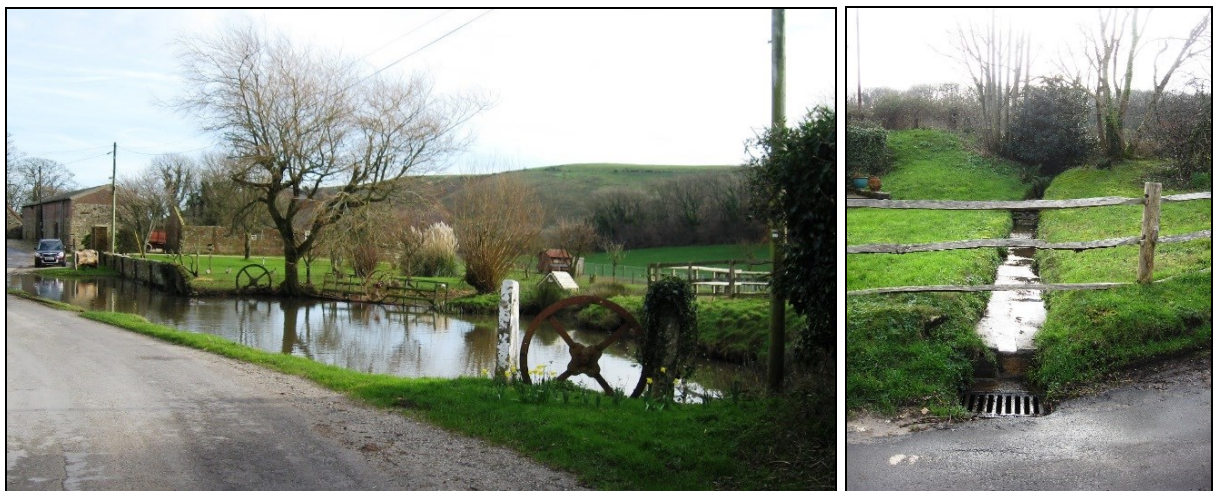
FIG. 14: *Duck Pond and stream. The pond (left) forms an attractive roadside feature passing through the hamlet, though its position makes it vulnerable to pollution from vehicles. The watercourse (right) is visible adjacent to Jubilee Cottage.*

71. The watercourse and ponds within the hamlet add to this diversity as well as contributing to the attractiveness and interest of the street scene (FIG. 14 below).

76. The duck pond (see FIG. 14 above) has a picturesque quality, though views around it are currently compromised by derelict structures, signage and poor quality surfaces. All provide opportunities for both improvement and enhancement.

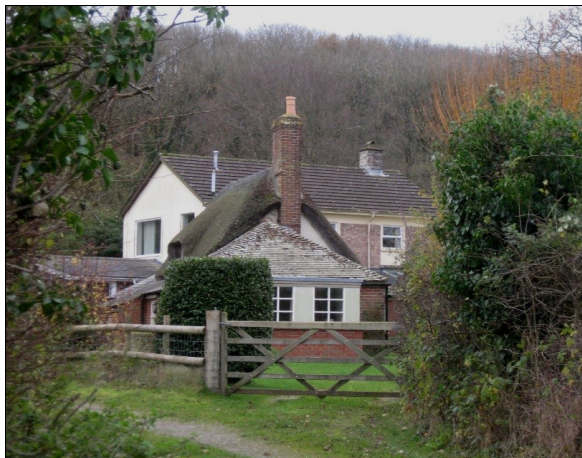
FIG. 16: *Little Cottage. The cottage is viewed with Squire's farmhouse in the background. The form remains distinct though much extended. Squire's farmhouse has clearly undergone extensive modification.*

- *Little Cottage* (FIG. 16): despite being almost encircled by extensions, the external form and character of this tiny historic vernacular cottage remains appreciable. The historic position on the edge of the former common may suggest that it originated as an informal encroachment.

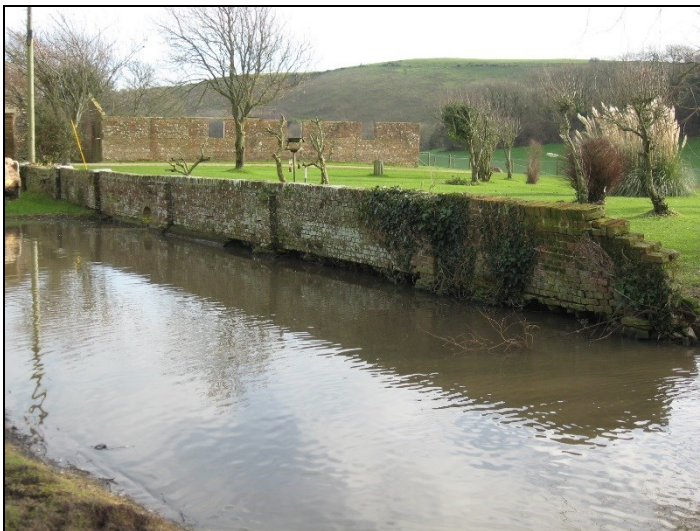
FIG. 17: *Garden wall opposite East Creech Farm. The brickwork is in poor condition, being damaged by ivy and leaning in places.*

80. Listed buildings and structures are termed 'at risk' where aspects of their condition, use or context threaten those features which provide special historic or architectural interest. The only listed structure of current concern is the garden wall and gate piers opposite East Creech Farmhouse (FIG. 17 below).

87. Sensitive repair of the listed garden wall, improvement of surfaces and reduction of clutter would all help to enhance the contribution this visually attractive part of the hamlet makes to the conservation area.
