# East Holme Conservation Area

## Appraisal document

Adopted Document

October 2015

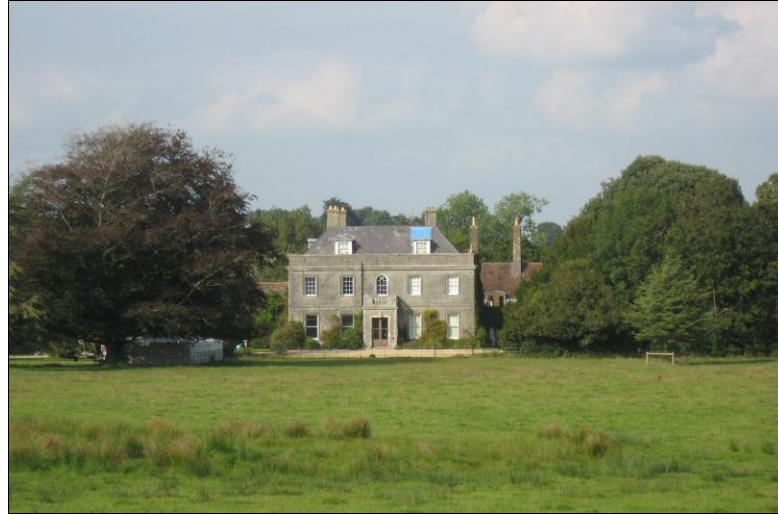
**FIG. 1:** *Holme Priory. View across the park from Holme Road, with frontage as modified during the nineteenth century. The driveway historically ran across the park to the right, though currently runs no further than the church.*

23. Holme Priory (see FIG. 1 below) underwent a series of enlargements during the second half of the eighteenth century, and early nineteenth century. Works undertaken to add stucco and raise the roof during the 1830-40s made a significant contribution to the way the property appears today. The adjacent stables contain elements of both eighteenth and nineteenth century date.

52. The vernacular (or traditional) pattern of construction is illustrated by The Cottage, and the principal part of Priory Farm (see FIG. 11), each of which are characterised by use of local materials. These buildings are easily missed given they do not stand on public roads, though agricultural buildings at the centre of the village similarly follow formats common locally, albeit the palette of materials is broader. The hipped cart porch of the former threshing barn is a distinctive element. East Holme Cottages (see FIG. 10) appears to represent an early example of formal cottage design, with pattern book (standardised) designs evident in late nineteenth century and later houses in the village. The neo-Gothic of the parish church (FIG. 9 below) follows a style fashionable during the 1860s. Holme Priory is mixed given the different phases of its construction, though the principal facades (see FIG. 1) follow a formal Regency arrangement.

60. Alongside tiles, slate is frequent within the conservation area and again became a popular rail during from the nineteenth century. The heather hue of slate covering the raised roofs of Holme Priory (see FIG. 1) appears to identify it as Welsh Penryhn.

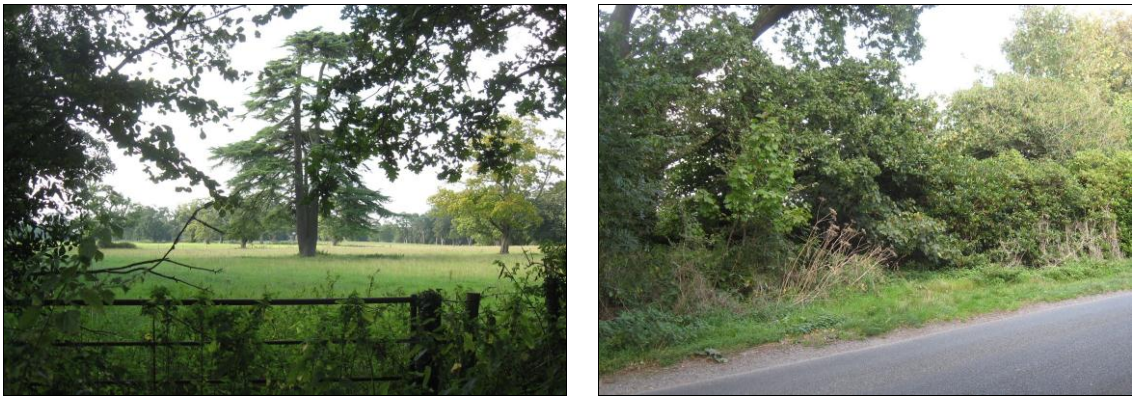
**FIG. 3:** *The old driveway. Left: former point of entry to the park with views of ornamental parkland planting beyond. Right: rhododendrons in the hedge adjacent to the former access.*

- 
25. Whilst the drive no longer exists the former entrance is still clear on the ground, marked at a kink in the road by a farm gate flanked by two aged trees. Vestiges of ornamental rhododendron planting survive in the adjacent hedge (see FIG. 3 below).

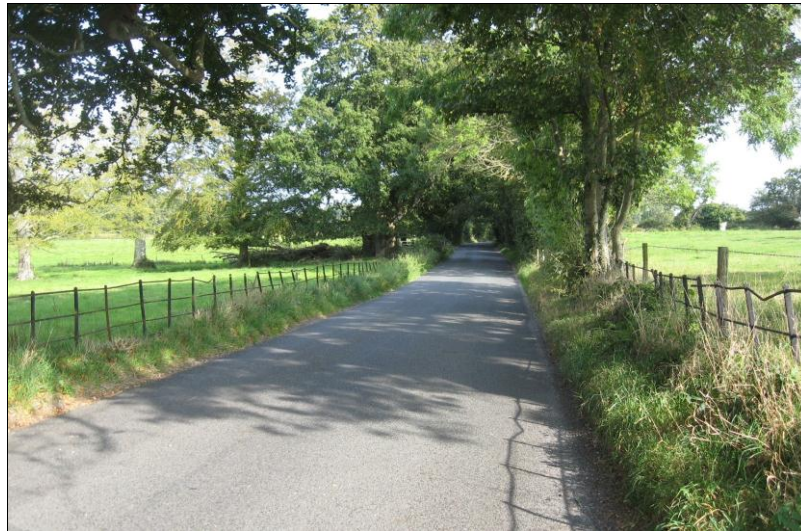
**FIG. 4:** *Estate railings. Here railings are viewed forming the parkland boundaries either side of Holme Lane, immediately opposite the house.*

38. Estate railings and gates are a notable nineteenth century feature of the park, and also occur along other boundaries within and around the village. The transparent qualities of the railings meant they were particularly suitable for subdividing spaces (such as parkland) intended to remain open for visual purposes, and this application is still appreciable where the park straddles Holme Lane opposite the house (see FIG. 4 below). Many of these railings are now corroded and in fragmentary condition, often hidden by undergrowth and scrub. Some prominent sections of railing have however been recently renewed.

43. As part of the late nineteenth century design of the park a drive was laid from its south east corner joining the current road adjacent to the church (see FIG. 2). South east of the church, a number of trees mark the former line of the driveway, whilst ornamental planting remains in the hedgerow adjacent to the historic entrance on Holme Lane (see FIG. 3). Though the drive no longer exists, the park continues to provide both the house and village with an attractive eastern approach (see FIG. 4).

44. The park straddles Holme Lane where ground rises immediately opposite the house (see FIG. 4 and 6), providing the property with long views. The park similarly straddles the lane entering the village, south west of the house.

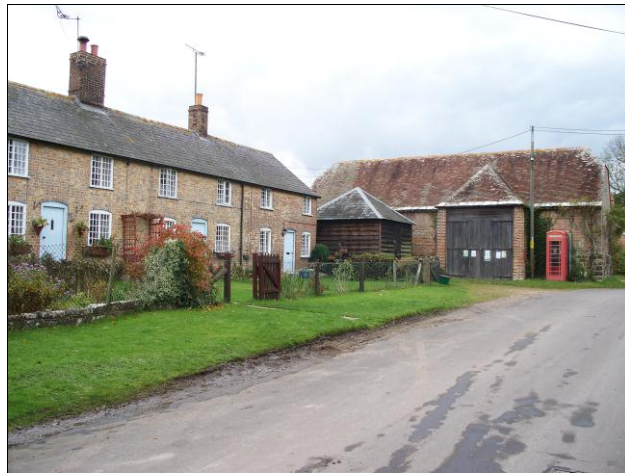
**FIG. 5:** *The centre of the village. An attractive grouping of listed buildings and structures whose positioning provides definition to the space.*

58. Plain clay tiles are used on various buildings. The barn at the centre of the village (see FIG. 5), parts of Holme Priory and the adjacent stable block also feature a stone tile easing course along the eaves. This feature seems to have been popular around the District during the eighteenth century, and in the absence of gutters, served to project rainwater clear of the face of the building on tiles roofs.

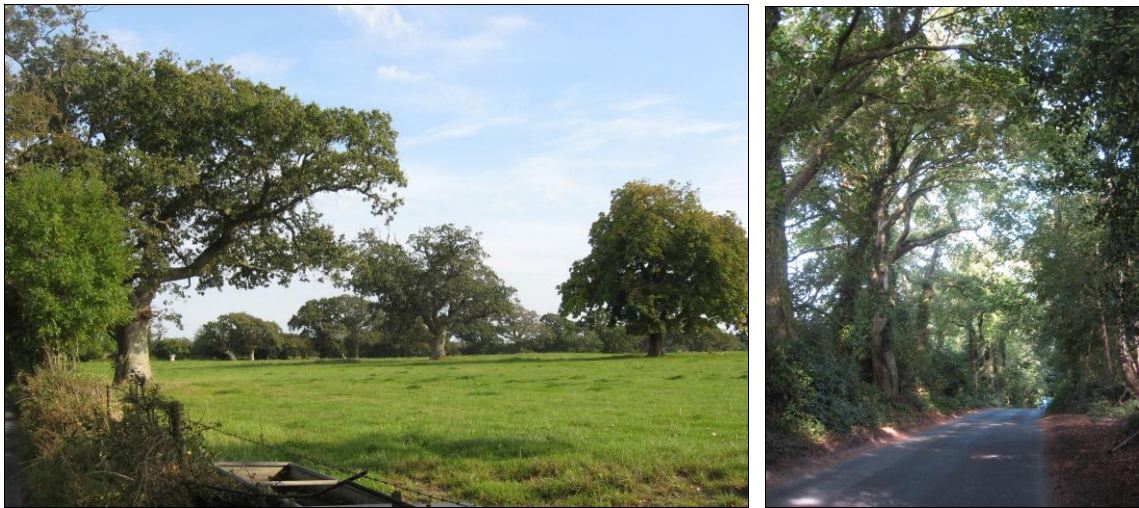
**FIG. 6:** *Trees. Left: view across parkland north of Holme Lane which contains a number of mature specimen trees and boundary planting. Right: tree canopy over Holme Road at Rookery Corner formed by trees of significant height.*

- 
45. Travelling west of the village along Holme Lane, trees either side of the road at Rookery Corner reach significant height, forming an attractive canopy (see FIG. 6).
  46. The quality of space at the centre of the village is particularly high (see FIG. 4 and 7). Here irregular verges are complemented by lightly enclosed front gardens, whose framing by buildings, boundaries and trees provides an intimate setting, sense of place, and a general feeling of seclusion. This is no doubt accentuated by the historic functional character of the space which serves a number of former agricultural buildings more commonly encountered in farmyard settings.

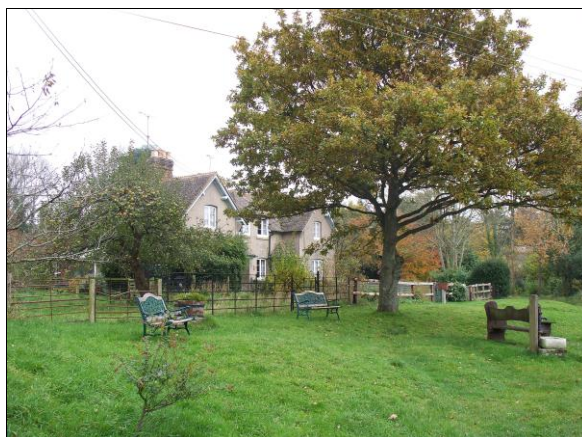
**FIG. 7:** *'Village green' with Priory Cottages behind. Note boundary treatments including post and rail and estate fencing whose transparent nature adds to a sense of spaciousness.*

48. The verge/green outside Priory Cottages is sufficiently broad to provide a seating place, and contains a number of benches (see FIG. 7).
49. Though a relatively late addition, the listed K6 telephone kiosk at the centre of the village (see FIG. 5) makes a good contribution to the scene. Together with the post box and informal use of the barn doors for notices, this provides the village with a distinct focus.

55. A number of buildings carry a grey self-coloured render finish, a treatment which seems to have found favour during nineteenth century. These include Priory Cottages (see FIG. 7) and Holmegate, which both date to the late nineteenth century, and principal facades at Holme Priory (see FIG. 1). Here render was added as part of the further remodelling of the house during the 1830-40s, and was typically intended to provide the impression of fine masonry construction.

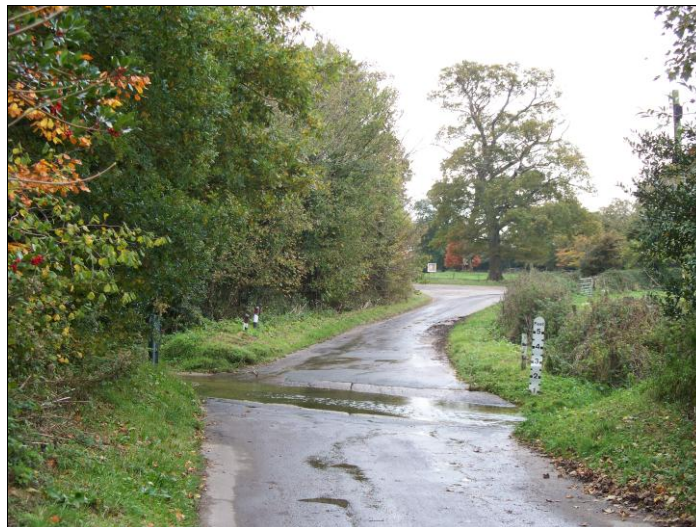
**FIG. 8:** *The ford. This is a distinctive feature entering the village from Holme Road. A second ford exists on Holme Road, though has now been by-passed.*

51. As the conservation area contains no pavements the groundscape is principally made up of tarmacked roads and the concrete-lined fords (see FIG. 8).

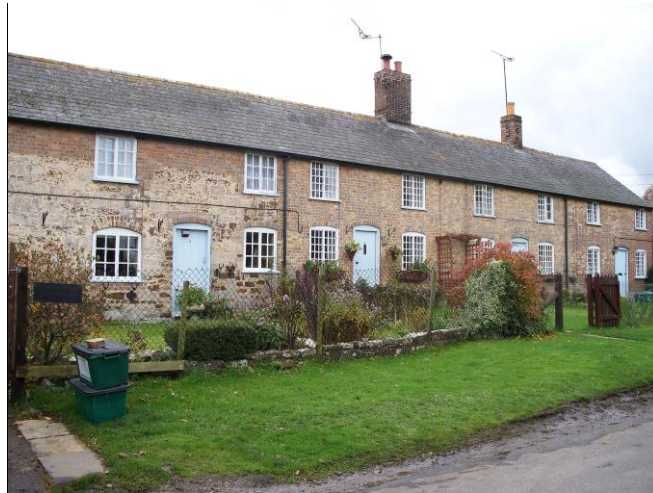
**FIG. 10:** *East Holme Cottages. No. 1 to the left incorporates heathstone in its construction, though the terrace is otherwise built using a buff brick. The terrace appears to have been limewashed in the past.*

21. The principal section of Priory Farm (see FIG. 11) is dated to the eighteenth century, and like No. 1 East Holme Cottages (see FIG. 10) features material derived from possible incorporation of earlier structures, or demolished monastic buildings. No. 1 otherwise forms part of an early nineteenth century terrace. Adjacent agricultural buildings may be roughly contemporary.

54. Brick is a principal construction material within the village, though as noted above, brick building sometimes also incorporate elements of stone masonry. The historic source of brick used in the village is unclear, though the buff and orange-red brick present fits the typical range of Poole Formation clays available in the vicinity. It appears that the brickwork of East Holme Cottages was previously limewashed.

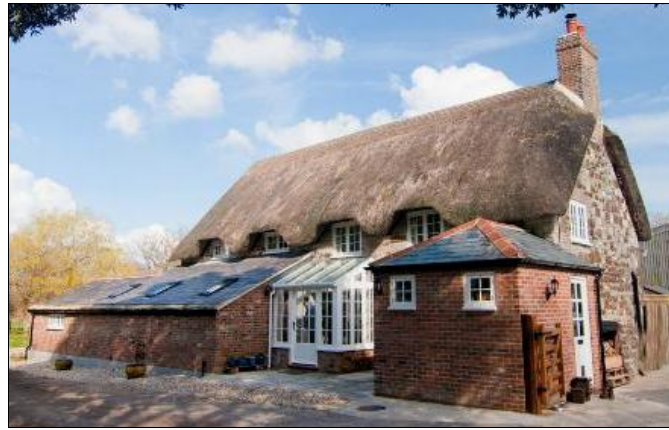
**FIG. 11:** *Priory Farmhouse. An eighteenth century building, possibly incorporating materials derived from former monastic structures, this is one of only two thatched buildings in the village. The walls of the cottage are heathstone, with later brick additions which greatly obscure the frontage.*

57. Thatch is present on two properties – Priory Farm (see FIG. 11) and Priory Cottage – where use reflects the broader historic vernacular in this part of the District. The history and relatively late period of development of much of East Holme however means that other forms of roofing material, including those imported from elsewhere in the country following establishment of the rail network, are characteristic in the rest of the village.

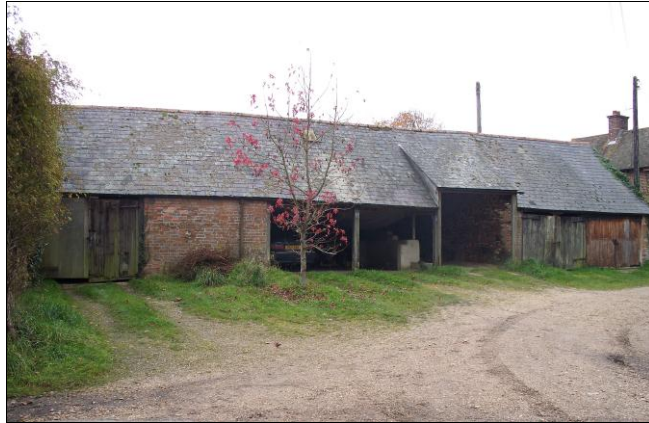
**FIG. 12:** *Cart sheds to the rear of the barn. Buildings such as these are particularly attractive to swallows.*

66. Buildings, watercourses and the conservation area's many trees and open green spaces provide nesting, roosting and feeding opportunities for fish, birds, bats and small mammals, and are also likely to support species of amphibian and reptile. Traditional agricultural buildings that have not been converted – such as those found at the centre of the village (FIG. 12) – are a particularly important resource for swallows who nest inside.
