# Herston Conservation Area Appraisal Document

Adopted Document

July 2008

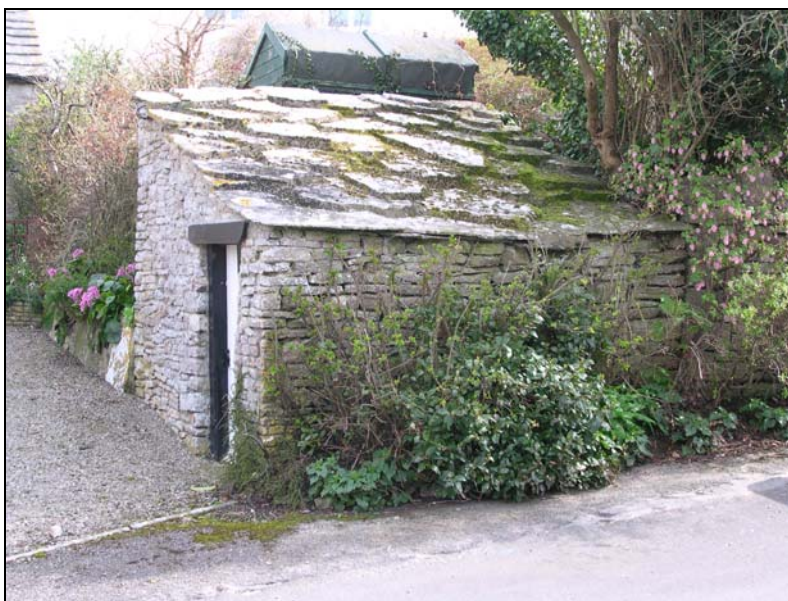
**FIG. 2:** *Rustic outbuilding. The heavy roof of rough-cut slabs is similar to the vernacular structures erected around quarry heads in Purbeck. Similar buildings survive in several locations around Herston.*

occupation by quarry workers. While many have now been gentrified the ruggedly roofed vernacular outbuilding of 25 Bell Street recalls the form of huts which photographs and prints indicate were often erected at quarry heads.

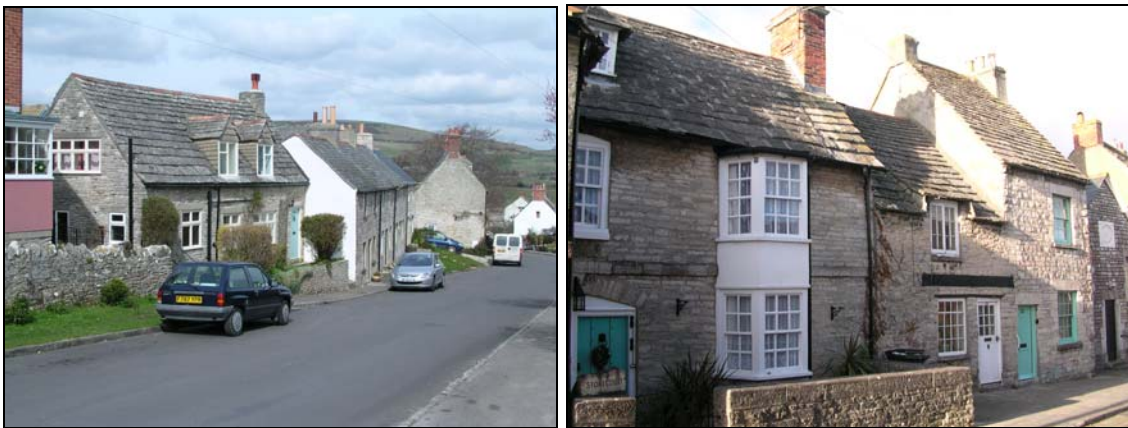
**FIG. 3:** *Compositions. Bell Street is filled with varied compositions. Above: three groups of cottages adopt an informal raking formation along the street edge. Below: varied roof shaped and building heights provide interest in this group.*

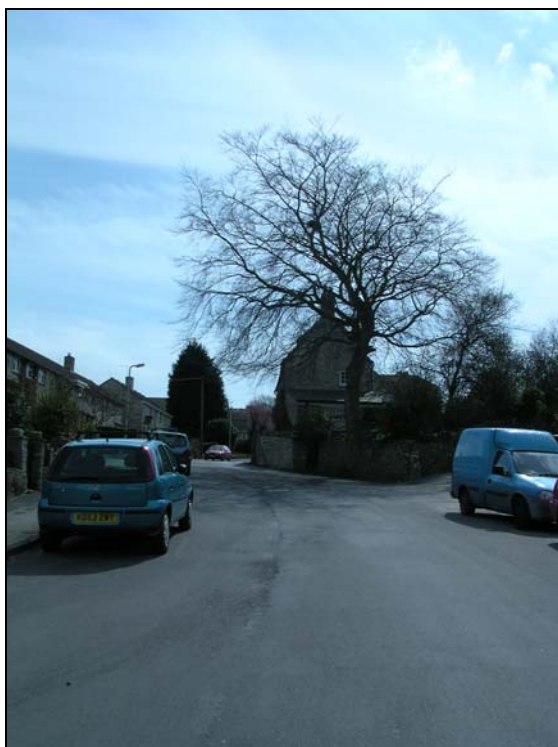
**FIG. 4:** *A landmark beech tree. The crooked silhouette of this tree means it provides a year-round contribution to the scene.*

- The beech tree located in the garden of 58 Bell Street is particularly prominent, its branches overhanging the road. This tree plays an important role in closing the long view up the street.
- A healthy young oak stands at the side of the east-west section of Jubilee Road. This should play an increasingly important role in the scene as it develops and has a potentially long future ahead of it.
- Open spaces (including gardens) around the junction of Jubilee Road and Bell Street moving west are particularly important in maintaining the spacious and informal nature of layout so fundamental to the character of the place. This has been harmed in the past by careless infill and encroachment upon the setting of the Area by more formal residential developments.

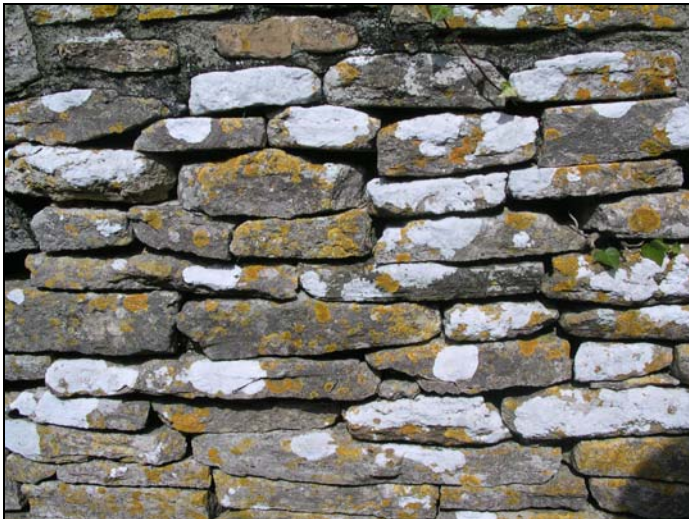
**FIG. 5:** *Traditional walling. Fine slabs of rubble neatly coursed. Note the attractive role played by lichen, indicative of good air quality.*

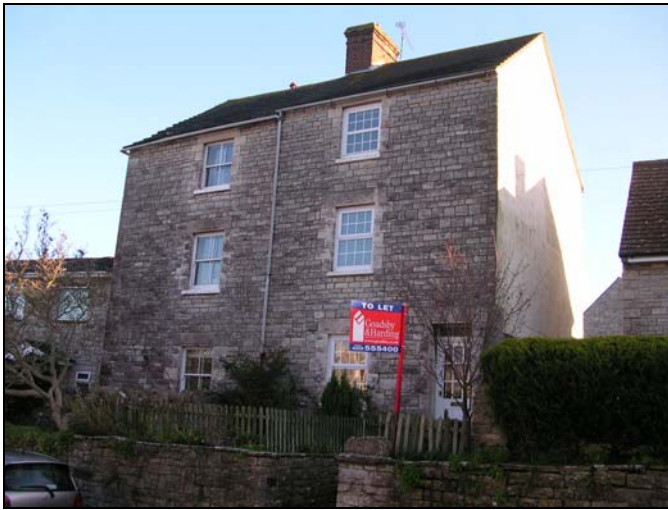
**FIG. 6:** *Poor window design. The house on the right has had its windows replaced. Manifestly plastic, their flat detailing is obviously superficial and the proportions used irregular and thick. Top opening they lack the profile of a sash window, while their 'Georgian' configuration has been applied to what is probably a Victorian building.*

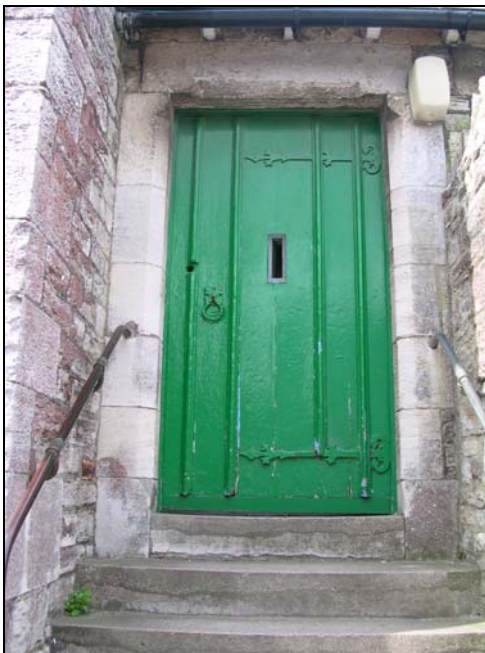
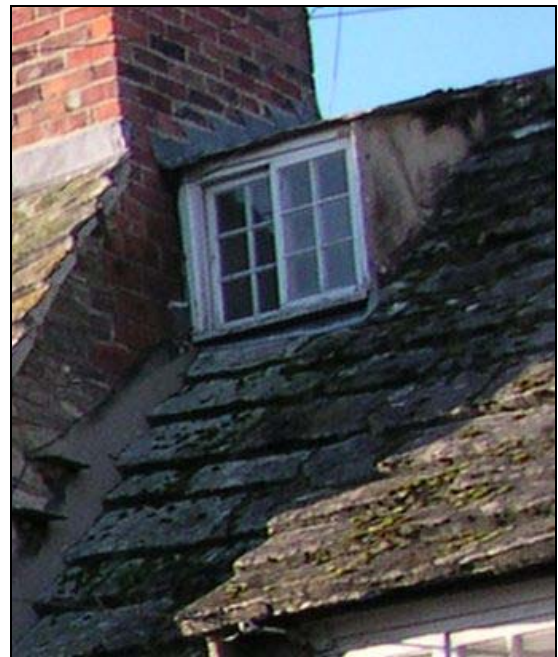
**FIG. 7:** *Door and window details. Left: the imposing gothic doorway into the school. Right: a Yorkshire sash window (horizontally sliding) in a dormer on 14 Bell Street.*

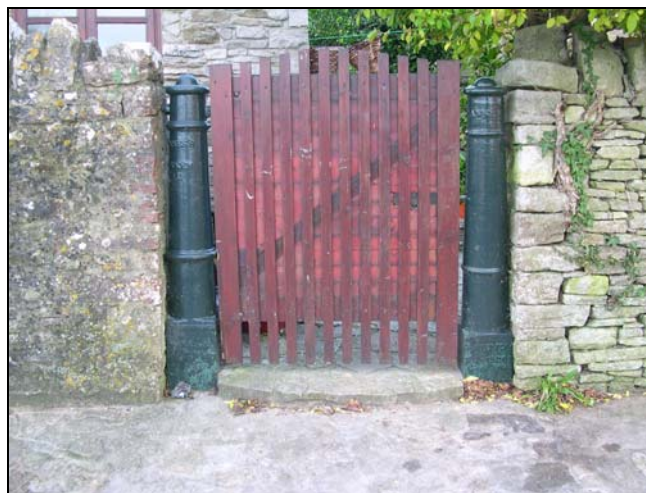
**FIG. 8:** *London bollards. 'St. James's' and 'St. Anne's'.*

- Four cast iron Regency bollards salvaged from London by local patron George Burt, and used to decorate both Swanage and Herston, now occur as gateposts along the east-west section of Jubilee Road. Two are embossed *St. James's* and *St. Anne's* (see FIG.8).
- Jubilee Road has two carved street name plaques while Bell Street has a blue and white enamel sign (in poor condition). Both types can otherwise be found in Swanage Conservation Area.
- Two narrow footpaths, one leading from Bell Street into Steer Road, the other from Jubilee Road toward Alderberry Close, are particularly interesting aspects of the urban structure. Outbuildings have been picturesquely constructed into the boundary walls of the former.

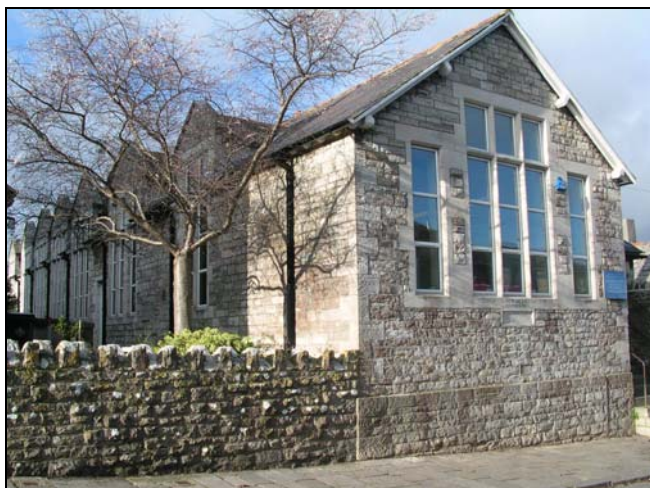
**FIG. 9:** *St. Mark's CofE School, Bell Street. The older part of the school has a bold presence. It is unfortunate that plastic windows have been installed.*

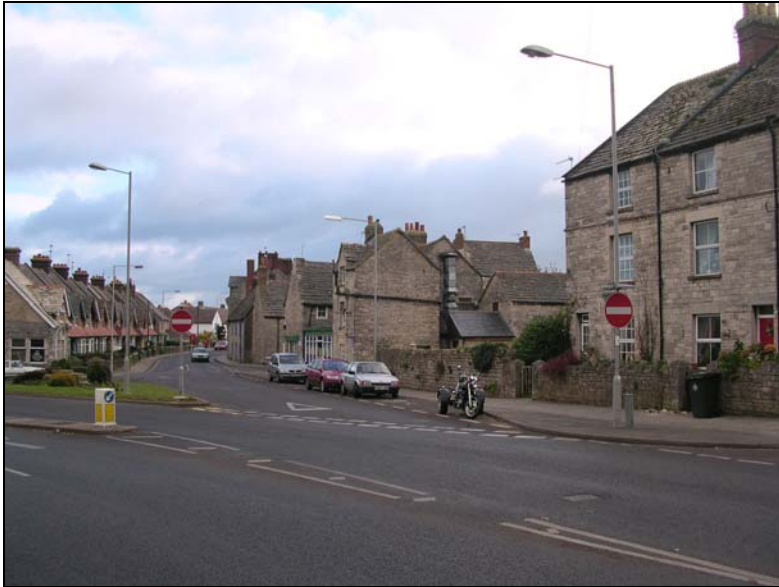
**FIG. 10:** *The 'Cross'. Today the former crossroads lacks definition as a result of its bypass and alteration in the pattern of use and traffic movement. As a former focal point within the village this treatment helps to undermine the identity of the 'place'.*

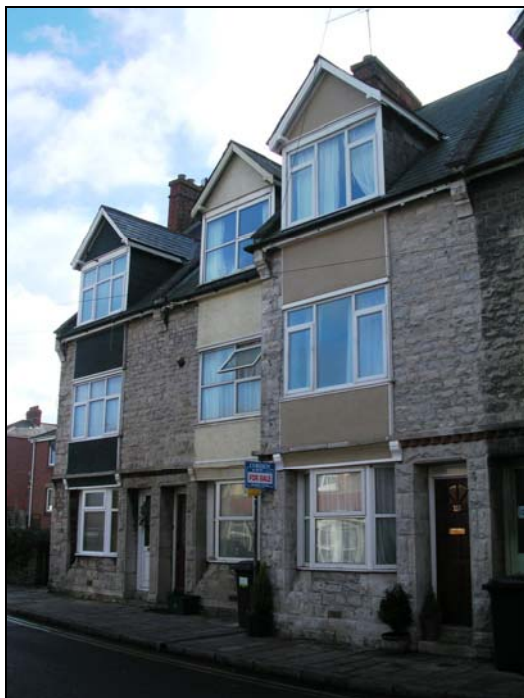
**FIG. 11:** *Building contrasts. Great variation is shown within the Zone in terms of plan-form, height and massing. The buildings pictured right however appear fairly incongruous.*

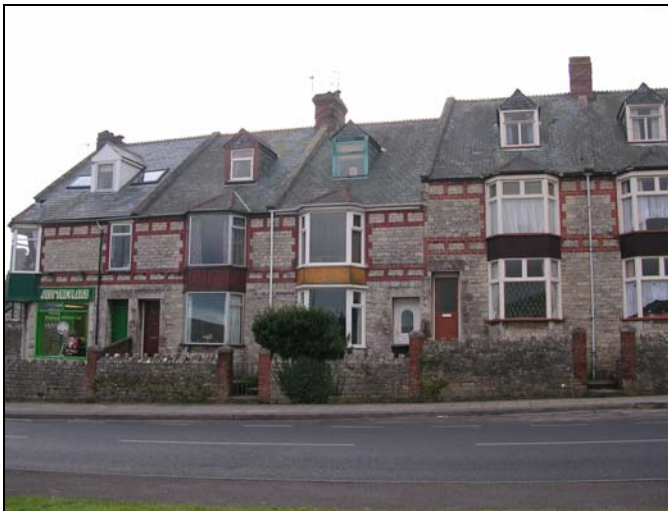
**FIG. 12:** *Brick detailing on stone. The combination of local stone with dark red Swanage brick is particularly characteristic of late nineteenth century development in and around Swanage. Note the range of unattractive alterations to windows, doors and roofs that have taken place.*

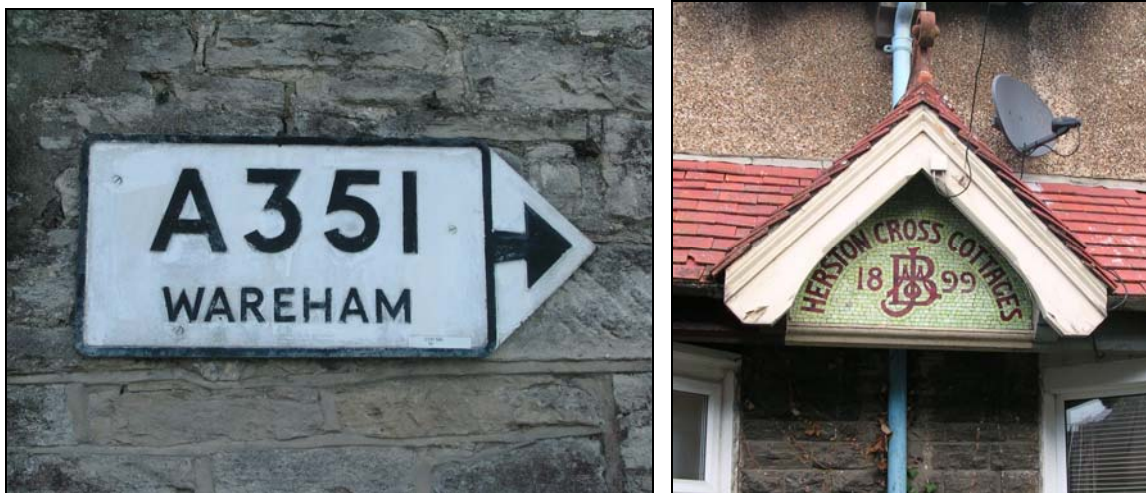
**FIG. 13:** Signs and plaques. Left: route sign to Wareham. Right: mosaic name and date plaque with inset monogram on Herston Cross Cottages. Note the satellite dish; positioning of these is controlled within Conservation Areas.

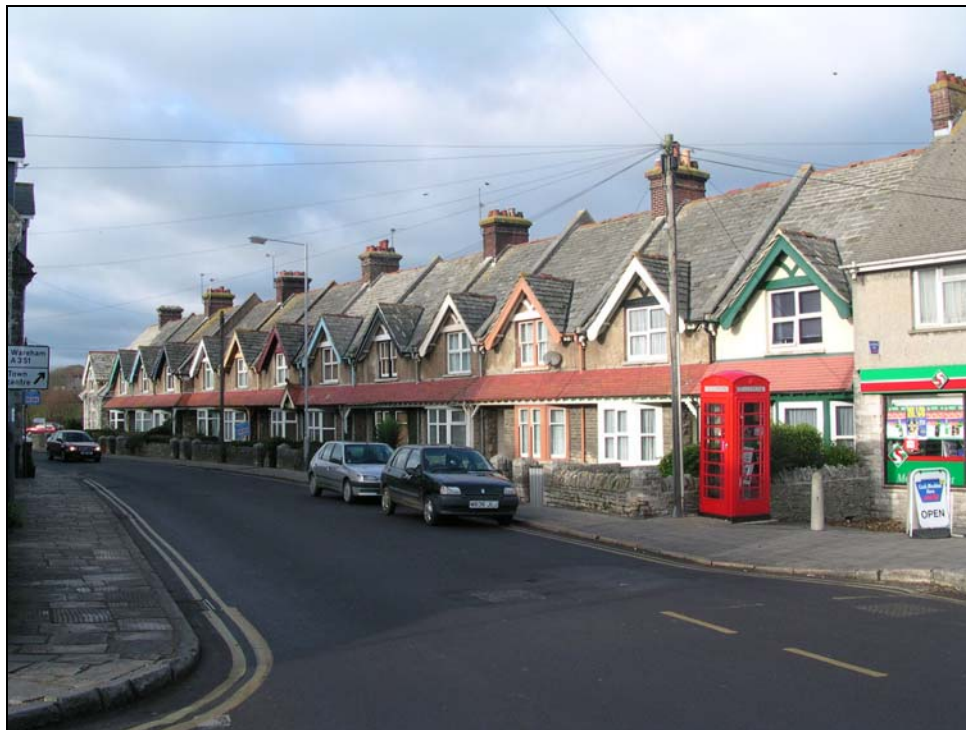
**FIG. 14:** *Herston Cross Cottages. An important feature at the top of the High Street. These display the vernacular revival ideal of using local materials in otherwise a fairly standard design.*

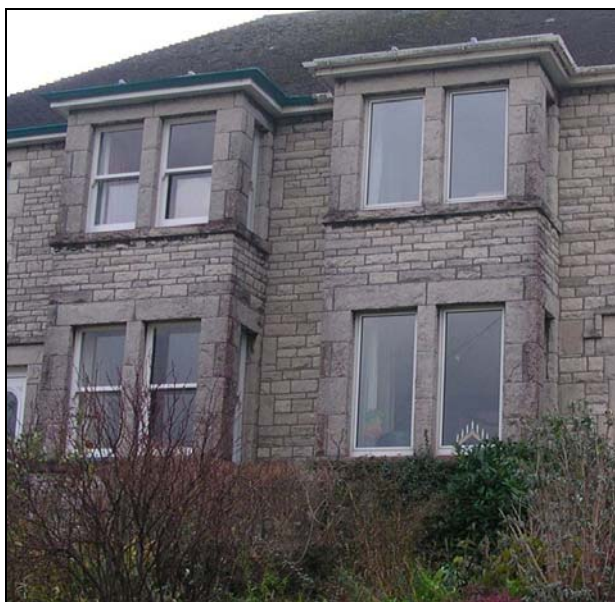
Replacement windows are a frequent blight particularly where PVCu or aluminium has been used. As in Zone 1 they rarely reproduce the historic pattern well if at all. This is especially noticeable where houses are paired or terraced (i.e. FIG. 18), the disorder visible in 355-367 High Street undermining the unity of design and giving an untidy and unattractive appearance.

**FIG. 15:** *Window contrasts. Sash windows have here been replaced with blank panels which give an uncharacteristically strong vertical emphasis and blandness to the facade.*

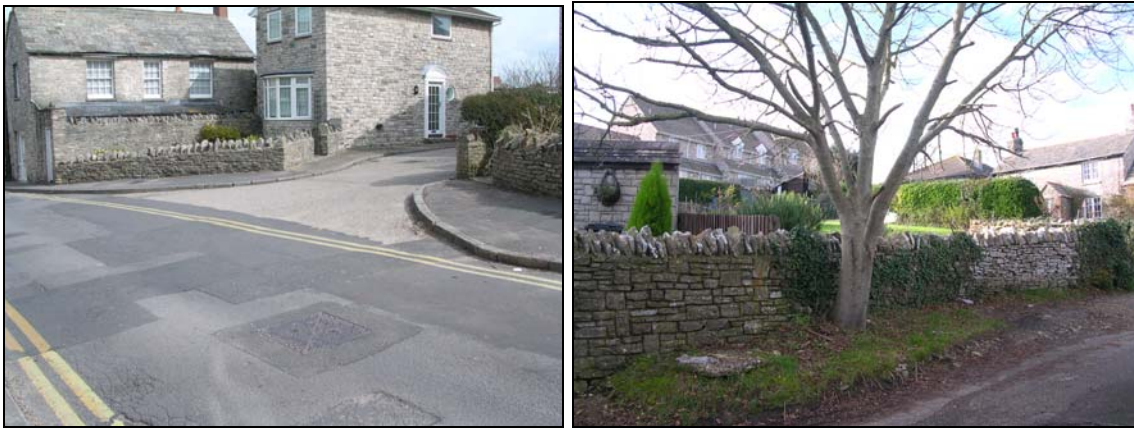
Intrusion upon the sense of place and character of the Area is all too apparent through encirclement on all sides but north by housing estate developments (those to the north absent on designation). These intrude where views are closed or accesses have been cut into the historic street layout. Relatively modern infill housing within Zone 1 adds little to the scene. The dense, orderly, staggered, repeating forms which stand along the lower part of Bell Street are particularly jarring given that they fail to respect the historic pattern of varied orientation and plan-form otherwise seen here. The modern highways practice of cutting broad accesses for side roads and drives spoils the sense of enclosure and historic spatial character.

**FIG. 16:** *Intrusion of modern development. Left: Prior to development of housing and insertion of an access here a high enclosure wall gave strong definition to the street edge. The concrete surface is particularly ugly. Right: The backs of modern houses built at the edge of the Conservation Area crowd and peer down into Jubilee Road spoiling the quality of space, privacy and views.*

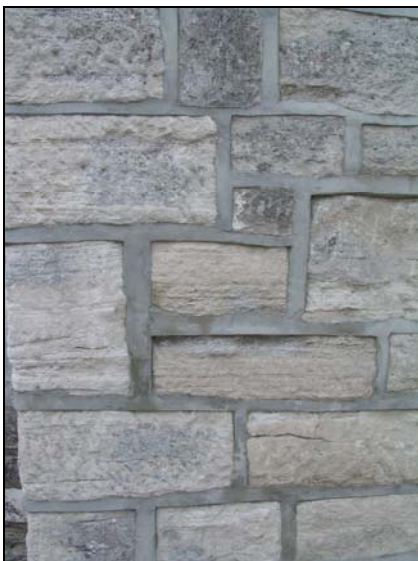
There are several instances in which buildings have been repointed using both inappropriate materials and methods causing visual and physical harm to be buildings concerned. Pointing should always utilise mortar which is weaker than the stone from which the building has been constructed; stronger mixes will cause erosion of the surrounding stone, trap moisture and eventually fall off. Appropriate mixes will be based upon use of either lime putty or feebly hydraulic lime (no stronger than nhl 2) *without* cement. Typical specifications may be 1 lime putty : 3 well graded sharp sand : 0.25 stone dust, or 1 nhl2 : 4 well graded sharp sand. Pointing should be finished flush between but not across the faces of adjacent stone and never raised as in FIG 17. This is visually harmful and will accelerate the process of stone decay. Where pointing of a listed building is to be carried out it will be necessary to agree this work with the Conservation Officer.

**FIG. 17:** *Inappropriate repointing. This building has been 'pointed' using a grey cement based mortar carrying a raised 'strap' finish. It is likely that the joints have not been properly raked out and that this has been applied over the top of an existing jointing. Not only is this visually unattractive but the hard and impervious nature of the mortar will cause severe erosion of the building stone along its edges.*
