West Lulworth Conservation Area

Appraisal document

Adopted Document

October 2015

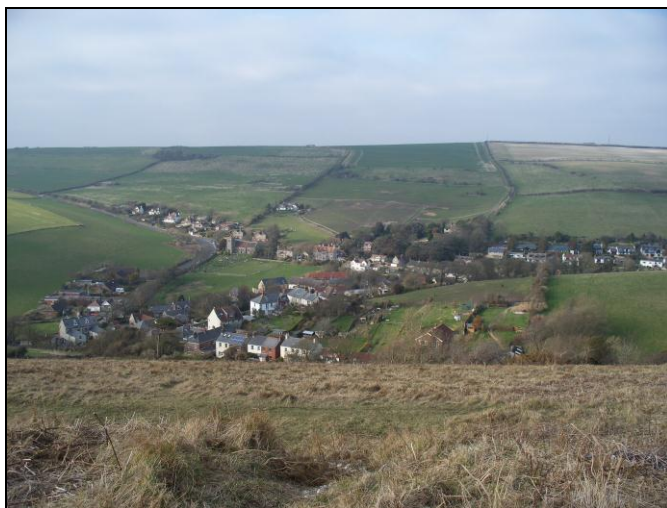
FIG. 1: *View of the upper part of the village from Bindon Hill. Most of the development visible is of post-1870, and largely twentieth century date, underlining the sheltered position of the historic village. Note the element of sprawl to the north-east and west, typical of the inter-war period.*

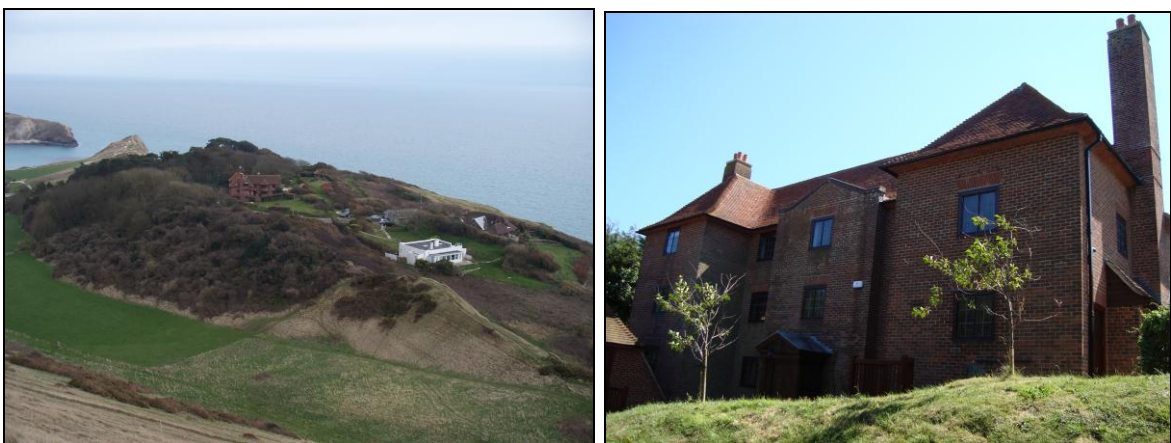
19. Britwell Drive (see FIG. 2). A residential development slightly detached from the historic village and characterised by large houses in spacious settings, which form a context for the Lutyens' designed 'Weston'.

FIG. 2: Zone 3. Left: as viewed from the coastal path on Hambury Tout. Right: Lutyens' Weston.

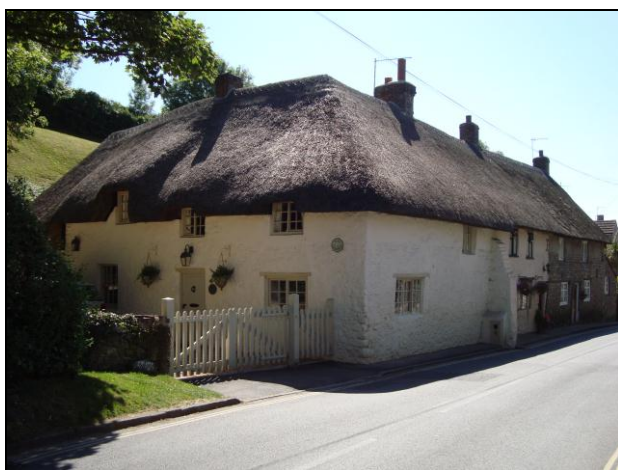
24. Nos. 7, 10, 27 and the row including Nos.11, 12 and The Old Bakery (see FIG. 3) are thought to find their origins in the seventeenth century. The seventeenth century saw purchase of the village along with the rest of the Lulworth Estate by the Weld family. The Estate continues to own much of the land and some of the buildings within and surrounding the conservation area.

FIG. 3: *The Old Bakery and adjacent cottages. The buildings have origins in the seventeenth century though were subsequently altered and extended.*

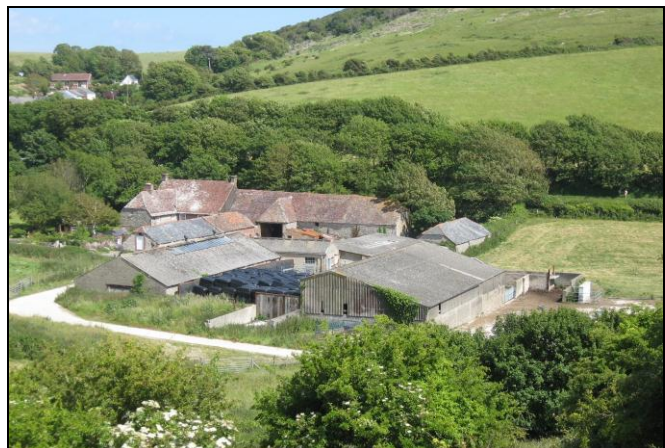
FIG. 5: Hambury Farm. The historic buildings carry tiled and slated roofs. The front of the barn faces towards the fields whilst the front of the house faces the road. Concrete and asbestos structures make unattractive additions.

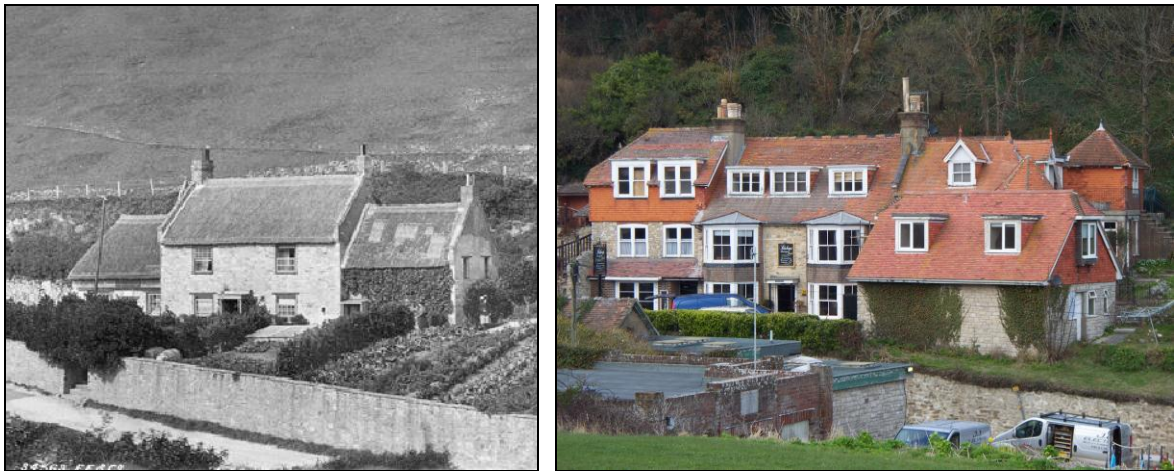
FIG. 6: *Remodelling. Left: A late nineteenth century view of the Old Post Office. Right: remodelled and restyled as Bishop's Cottage. Note the relative absence of trees in the past.*

68. Large late Victorian/Edwardian suburban forms with standardised arts and crafts detailing are scattered through the conservation area. Many of these buildings find origin and continuing use as hotels, highlighting the continued growth of tourism at this time. Houses of the period are a key feature of Britwell Drive (Zone 3), which includes the only Lutyens design in Dorset. In terms of both style and construction most of these buildings again usually have little or no affinity with the vernacular context, though Bishop's Cottage (see FIG. 6) is an interesting exception given its design incorporates and is adapted to a pre-existing building.

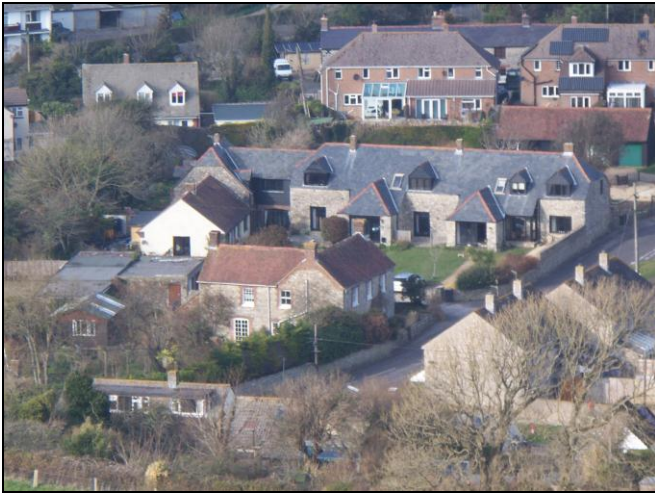
-
36. Conversion of agricultural buildings at West Lulworth Farm took place during the 1970s, and houses were built in the old rick yard above (see FIG. 7 below). The Old Barn on Main Road was an earlier conversion, but its current appearance bears little resemblance to the agricultural building shown in old photos.

FIG. 7: *West Lulworth Farm viewed from Bindon Hill. The barns have been thoroughly domesticated, and the crowding of modern suburban development within the immediate setting is apparent.*

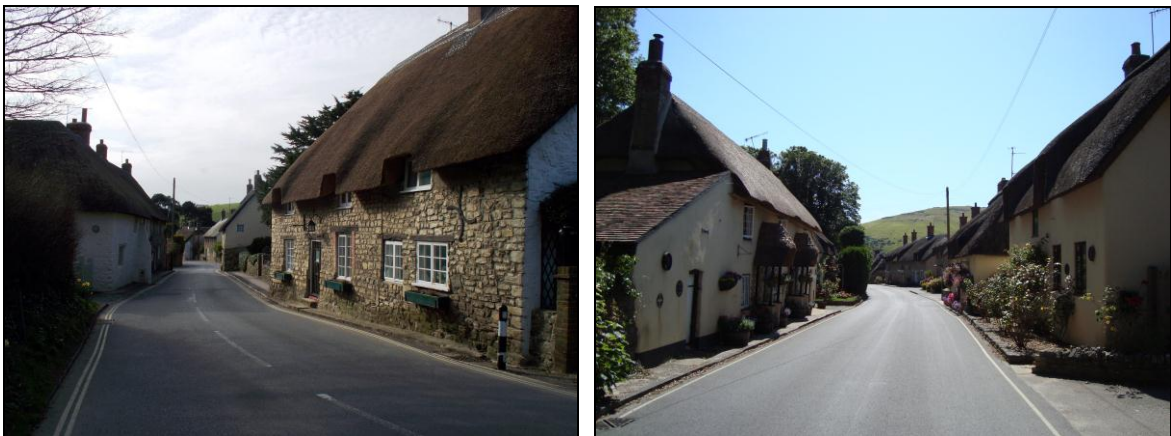
FIG. 8: Views along Main Road. Vernacular architectural character is strong and has been reinforced in the right hand view by sympathetic modern development. Note the visual presence of Hambury Tout.

40. The historic layout was elaborated by mid nineteenth century addition of Church Road, and the link forming the north side of the Triangle which provided a more direct access into and out of the village. Sunnyside, The Launches and Bindon Road each trace the line of pre-existing tracks, Sunnyside reverting to this status at its end. Both Sunnyside and The launches run at high level either side of the coombe, shadowing the historic roads below. This provides the modern townscape with a degree of depth, and, where connecting paths link to the roads below, permeability, though the layout of pre-1870 development itself generally lacked such depth, being strongly linear in its arrangement (see FIG. 8 above). The recent Shirley Close development runs counter to the general pattern.

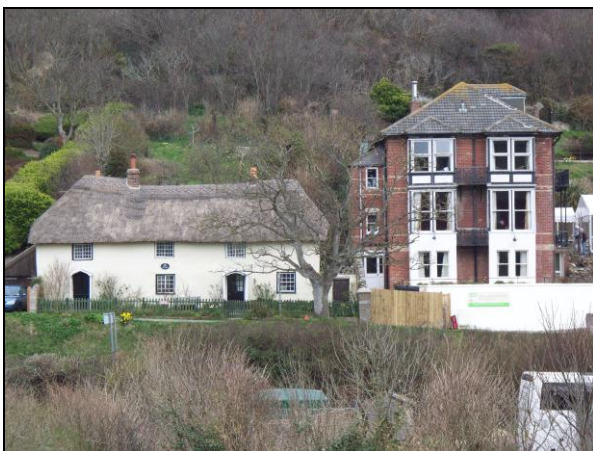
44. Pre-1870 buildings throughout the conservation area typically have either one and a half or two storeys, with overall height relatively low due to shallow floor to ceiling heights. Evidence for a past increase in the height of some cottages can be seen on end gables, and where walls appear to have been raised using cob – see particularly No.13 Main Road (whose first floor windows have been repositioned) – No. 7, No. 26, and No. 12 Main Road. Whilst some twentieth century bungalow forms are of similar stature, differences in terms of style and plan form otherwise provide sharp contrast.

FIG. 9: *Rose Cottage and West Lulworth House Hotel. Rose Cottage demonstrates typical vernacular style and form. West Lulworth House Hotel meanwhile is one of the least sympathetically designed late nineteenth century buildings, contrasting with its neighbour in terms of height, materials, style, form and orientation.*

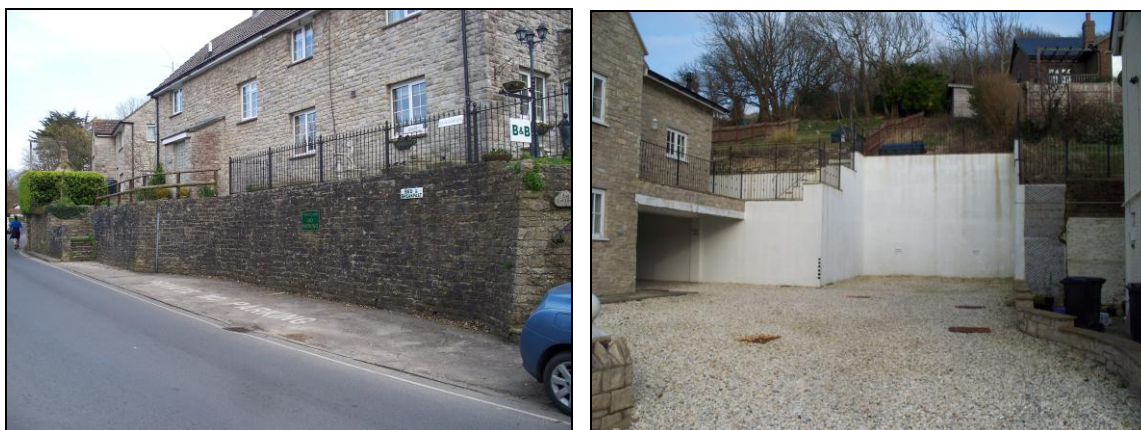
47. Through Zone 1 the street is generally enclosed by buildings, or associated boundary walls or hedges. Continuity of historic character is however broken at intervals by driveways, or parking areas which have been laid out to open directly onto the street.

FIG. 10: *The negative visual impact of retaining walls and pulling in spaces.*

48. Steep retaining walls are a repeated feature through Zones 1 and 2 of the conservation area. Whilst these are a historic feature on the east side of the road leading to the Cove, in many places they more typically represent modern interventions to enable development on steep banks (see FIG. 10 above) or to form parking and yard areas. This contrasts with the historic pattern of fitting development to landform, and can appear visually obtrusive given the harshly

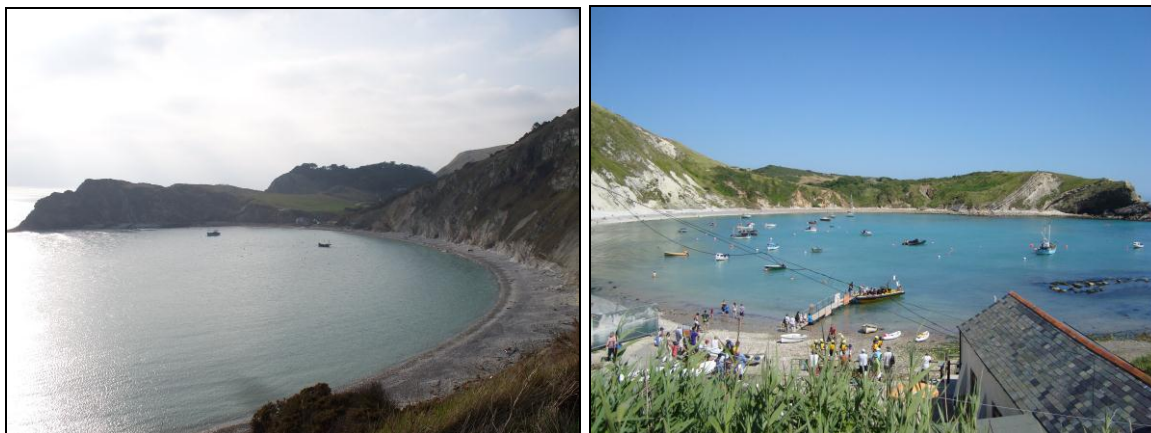
FIG. 12: *Two views of Lulworth Cove. Note the nineteenth century boathouse (left), and seasonal contrast.*

- *Boathouse at the Cove (see FIG. 12):* The boathouse has been present since at least 1839, and may be associated with Coastguard Cottages which were constructed in the 1820s. The slipway has been removed/eroded leaving the building oddly detached from the beach, though the building itself nestles into the slope. It represents a subtle human intrusion into the natural form of the Cove, telling of the historic and continuing connection of the village to the sea. The building is currently disused and over the long term may be at risk of being damaged by storms, as was the former coal store (Cove Café) opposite during 2014.

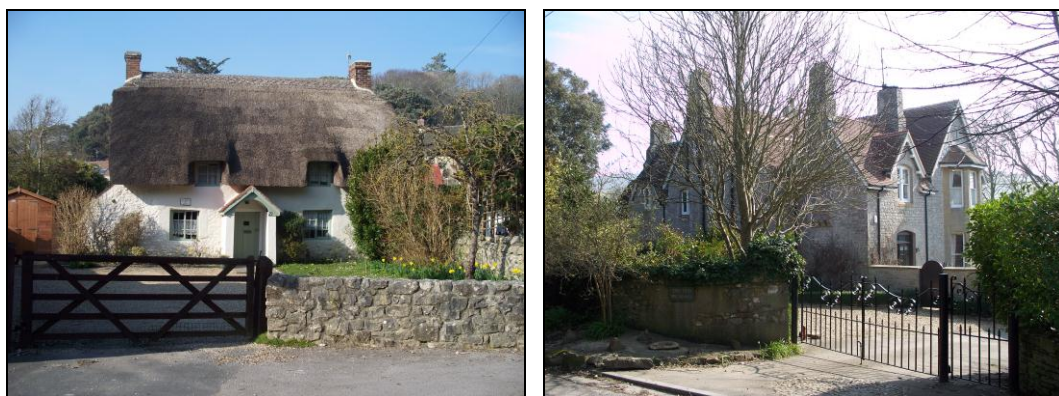
FIG. 13: Architectural contrast. Top left: late eighteenth century vernacular. Top right: mid Victorian neo-Gothic. Bottom left: cottage orné. Bottom right: typical 'Edwardian' arts and crafts villa.

-
67. Development from the 1870s to the end of the century began to reflect the economic forces driving growth in other coastal towns and villages in the region as tourism and communication networks began to expand. Development of the period shows little architectural consistency with earlier vernacular forms, and is characterised by the application of generic style and pattern book designs of often urban type. A concentration of such forms occurs in the vicinity of Sunnyside and Bindon Road which includes some speculative housing. Notable buildings include the imposing Old Vicarage which has neo-Gothic overtones (see FIG. 13), and Covebank/Grey House which occupies an important focal position.

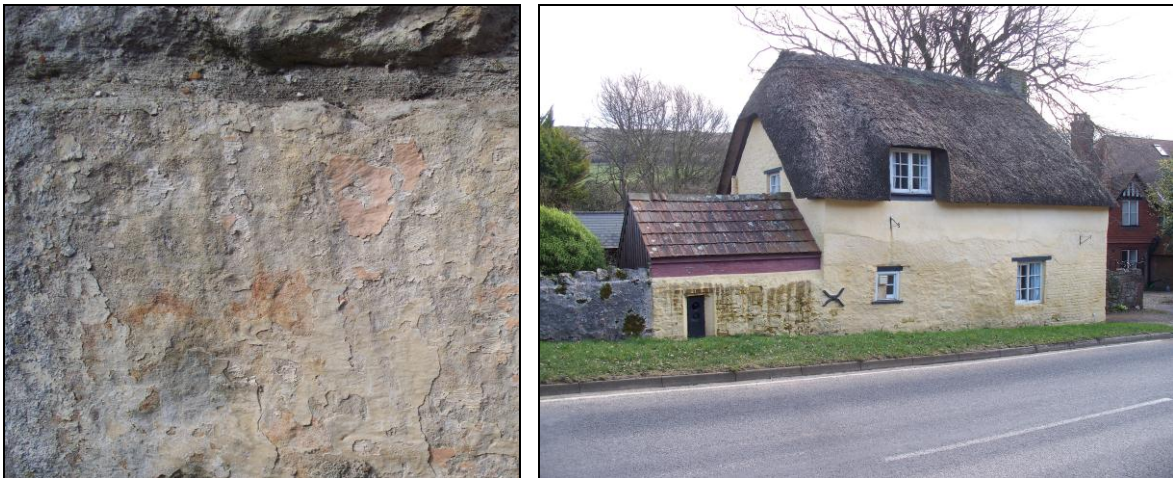
73. Limewash was a historically common finish for rubble buildings across the District, and provided practical protection from the elements for poor quality stonework. In the absence of such protection the erosion of mortar and stone alike is accelerated, and is evident at a number of properties along Main Road, particularly where exposed to backwash from traffic. Whilst many pre-1870 buildings within the upper part of the village retain a limewash finish (typically, though not ideally covered over with masonry paint), this has clearly been lost at Nos. 10/10a, 12, 17-20, 30/31 and No. 14, given fragments adhere to the frontages of each (in the case of No. 14 revealed beneath detached sections of twentieth century pebbledash). See FIG. 14 below. Reinstatement of the original finishes may be beneficial in terms of both protection, and reinforcement of local distinctiveness.

FIG. 14: *Limewash. Left: traces of historic limewash finish at No. 12 Main Road. Right: renewed limewash finish at No. 7 Main Road – a building whose roof has clearly been raised (see render line with traces the original eaves level).*

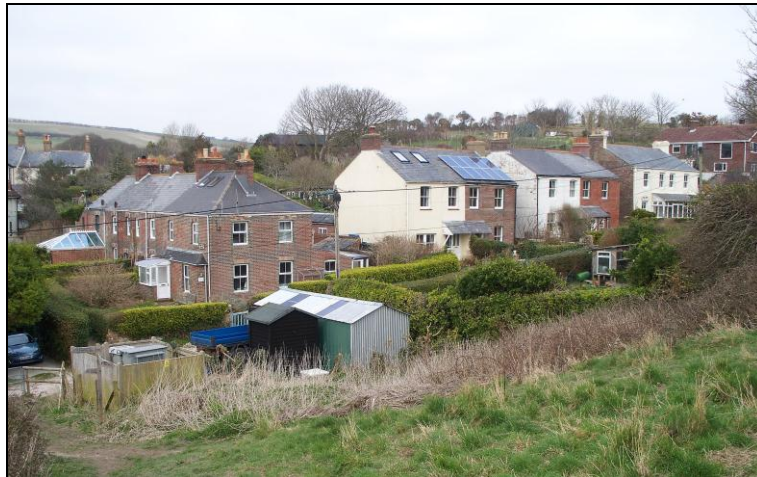
FIG. 15: *Brick along Bindon Road. In contrast to development generally, though in common with contemporary development, buildings here are characterised by use of brick. The urban, pattern book character of houses similarly contrasts with vernacular development, though together the houses form a distinct group whose back lane setting is enhanced by the allotments opposite and rough finish of the track.*

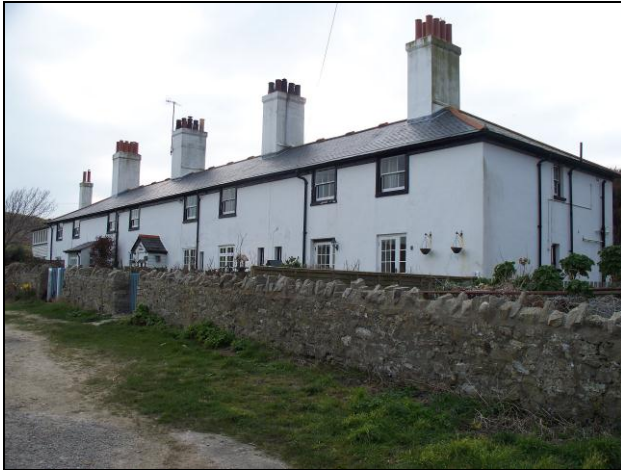
84. Chimneys play an important, traditional role in characterising the roofscape of the conservation area. The stacks of cottages are generally modest, simple brick designs, whilst more substantial and ornately detailed chimney stacks feature on late nineteenth and early twentieth designs. Those of Weston are visible above the trees of surrounding landscaping from a long distance. The chimney stacks of coastguard Cottages are a particularly striking and distinctive feature of the building (see FIG. 16 below), as too are those of Wilton Cottage.

FIG. 16: *Coastguard Cottages. The towering chimney stacks are the most distinctive feature of the building, their presence emphasised by the relatively shallow pitch of the roof. Modern vents set in the ridge are a visual distraction.*

109. The gradual replacement of modern block ridges on thatched roofs for more traditional flush details would help to reinforce local distinctiveness. As ridges are typically renewed every 10-15 years this can be achieved relatively quickly by

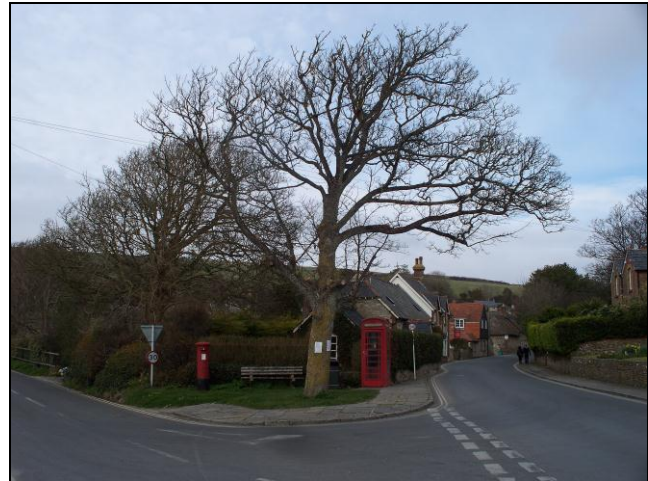
- *K6 red telephone kiosk (FIG. 17 below):* The K6 kiosk with jubilee crown (1936-53) located at the junction of Main and Church Roads occupies a focal position, which together with a contemporary (George V) pillar box flanks an attractive sycamore.

FIG. 17: *Junction of Main Road with Church Road. Two ‘classic’ items of British street furniture flank a visually significant sycamore tree.*

56. Trees which make a particularly strong contribution to townscape character include the somewhat mutilated but visually significant sycamore that stands at the junction of Main Road and Church Road (see FIG. 17), and the yew trees which stand in the old churchyard on Main Road.

64. Surprisingly the village retains three K6 red telephone kiosks. One of these – the kiosk opposite the Castle Inn – is listed. The kiosk located at the junction of Main and Church Roads has some townscape value (see FIG. 17), though that located adjacent to the visitor centre in Zone 2 appears poorly positioned.

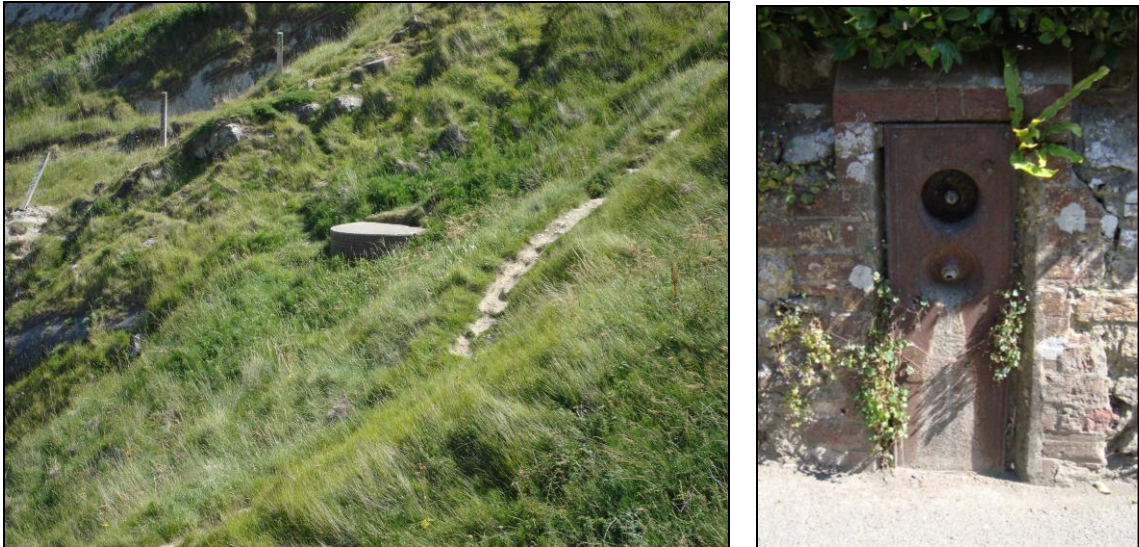
- *Pillbox in the side of the Cove (see FIG. 18 below):* A cylindrical concrete pillbox exists semi-buried in the cliff on the west side of the Cove. This formed part of the network of coastal defences constructed during World War II.

FIG. 18: *Features of interest. Left: cylindrical concrete pillbox concealed on the west side of the Cove. Right: old water tap.*

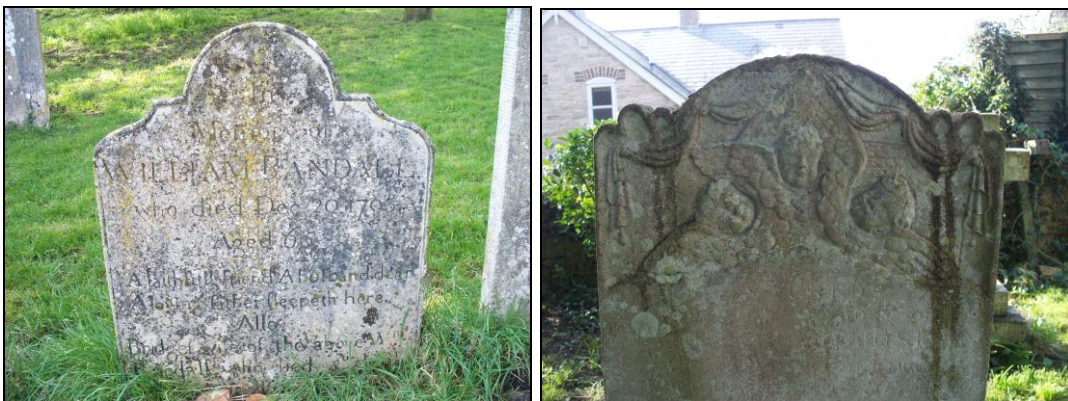
- *Tombstones in the old churchyard (see FIG. 19 below):* The churchyard contains a number of interesting late eighteenth and early nineteenth century monuments, some of which carry ornate carvings. That to William Randall carries a personalised and poetic dedication.

FIG. 19: *Headstones in the old churchyard. Left: monument to William Randall and his wife, which is of interest for the dedication it carries. Right: a good example of the carved ornamentation seen on a number of monuments here.*

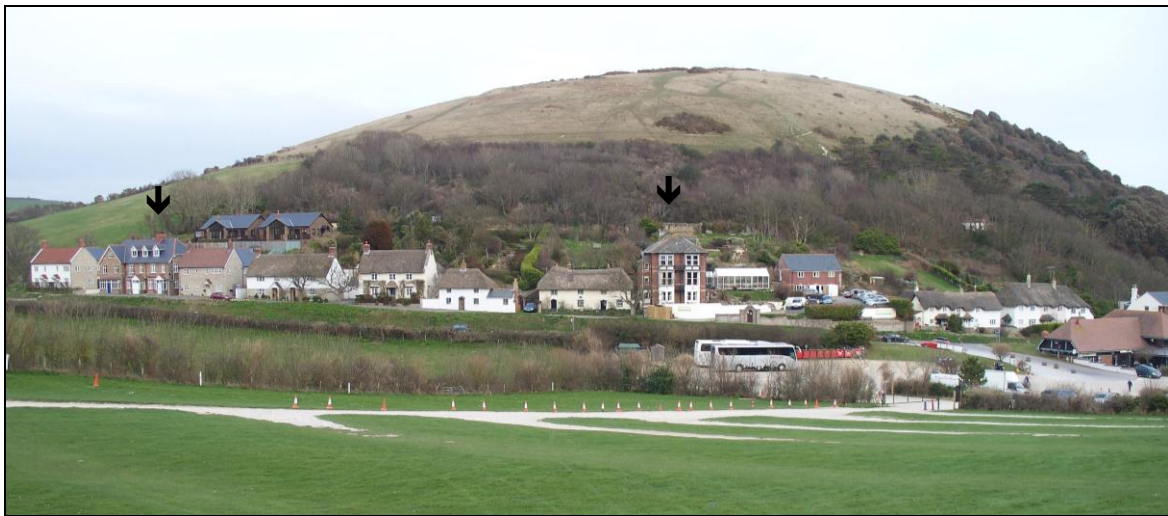
92. Whilst there has been a recent return to popularity of building designs which seek a vernacular character, the details used often fail to accurately reflect those used in the locality itself, undermining its distinctive character. Greater care is therefore needed in the detailing of new buildings. A further weakness of some recent development has been the tendency to take a cue from the immediate context, regardless of whether this is itself characteristic of the broader context generally. This tends to further dilute rather than strengthen character by producing a clustering effect (see FIG. 21 below).

FIG. 21: *Modern development in context. Most of the buildings visible are post-1870 date, many of these post-1990. Prior to 1870 development here was of vernacular character, exemplified in terms of character and scale by the two intact late eighteenth century cottages centre view. Whilst these have provided a model for some modern development, others have taken West Lulworth House Hotel and Lulworth Lodge (arrowed) – late nineteenth century buildings whose form, style and materials paid no regard to context – as references for development immediately adjacent. The ‘clustering’ effect this has had has further weakened character in these locations. Note the intrusive character of buildings set at higher level.*

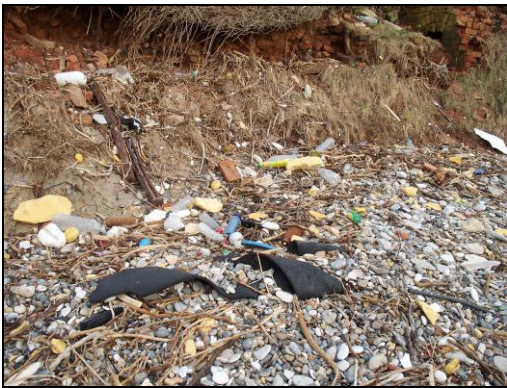
95. Significant quantities of rubbish and debris from fishing nets is washed ashore in the Cove, particularly during winter (see FIG. 22 below).

FIG. 22: *Rubbish on the beach. Large quantities of rubbish washed ashore during winter storms in 2014. Debris from fishing nets is frequent. Note the remains of a brick building behind, removal of which could be beneficial.*

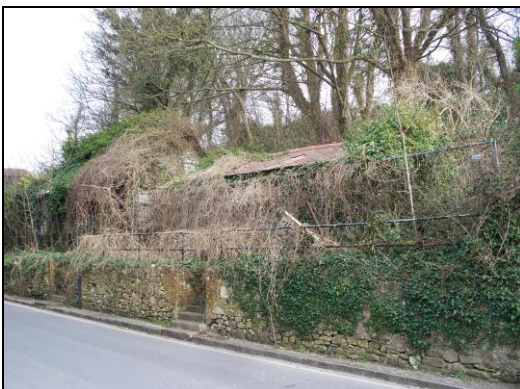
96. The conservation area contains a surprising number of derelict buildings (see FIGs. 23 and 24 below). In the Cove these include the site of the former café and the remnants of a brick building of unclear origin, and inland, the fire damaged shell of the squash courts, the overgrown village stores and coach house to the rear of Cove Cottage.

FIG. 23: *The former stores on Main Road. Currently abandoned and overgrown.*

106. Addressing the condition of derelict buildings and sites through rehabilitation, redevelopment or clearance and site restoration could potentially be of great benefit.

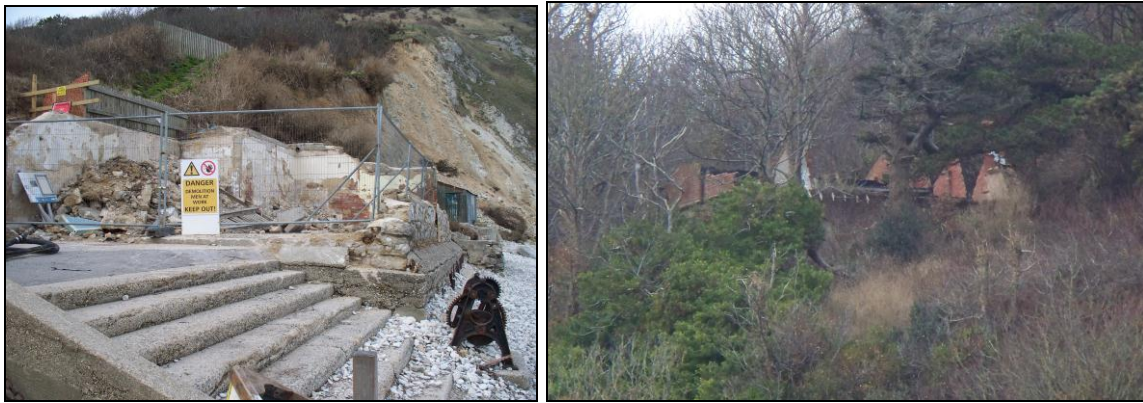
FIG. 24: *Dereliction and ruin. Left: remains of the Cove Café. Right: remains of the Edwardian squash courts.*
