Winfrith Newburgh Conservation Area

Appraisal document

Adopted Document

December 2014

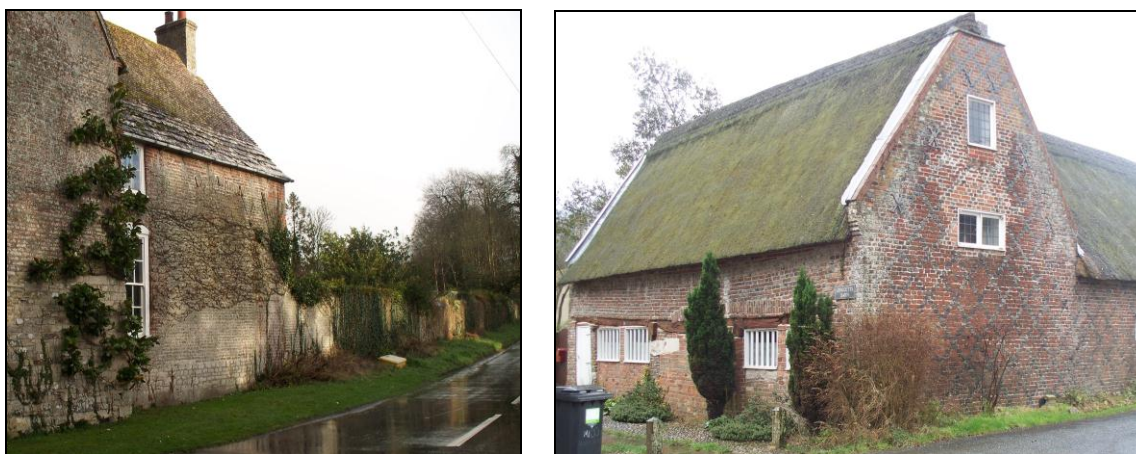
FIG. 1: Sixteenth century brickwork. Left: The rear range of the Manor House and boundary wall have both been dated to the late sixteenth century. A former brick lintel of a long blocked window is visible, showing the extent to which the building was restyled in later centuries. Extensive overgrowth by ivy and other climbers is of concern. Right: Longcutts Barn, which has decorative 'daiper' work (criss-cross pattern). The building originally had a tiled roof.

50. The conservation area contains some remarkable examples of early brickwork. The rear range of the Manor, its boundary wall and Longcutts Barn (see FIG. 1) have been dated to the late sixteenth century, whilst Manor Cottage (former service range to the Manor), has been dated to the seventeenth century. Longcutts Barn displays 'daiper' work (a patterned finish created by use of bricks of contrasting colours in English cross bond). The boundary wall of Winfrith Cottage appears to make use of brick of a much earlier date than the cottage itself, though its origin is unclear. Until the later nineteenth century, large scale use of brick within the village appears to have been limited to prestige contexts such as Winfrith House, the Manor House and associated structures. Prior to this time the use of brick in vernacular construction was generally limited to chimney stacks and the definition of openings, though Little Rhylecombe represents an exception, brick being one of the three materials historically used in construction of its walls (see FIG. 13 below).

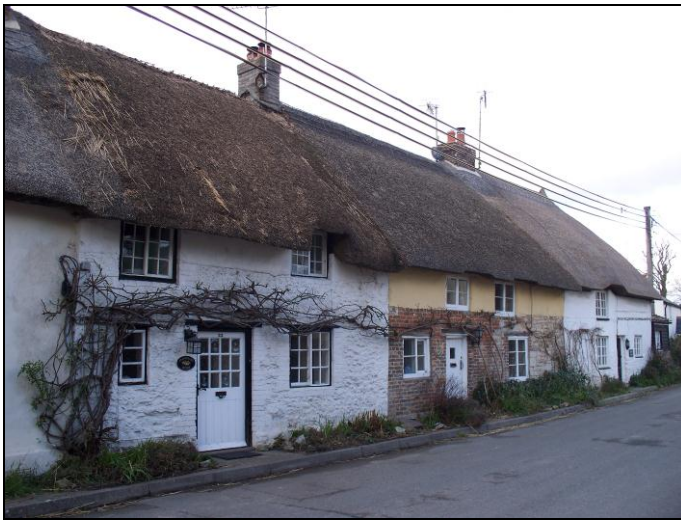
FIG. 2: *Seventeenth century cottages. Nos. 20-22 originate during the period though the facades with their mixed building materials show evidence of modification over time, including possible increase from one and a half to two storeys.*

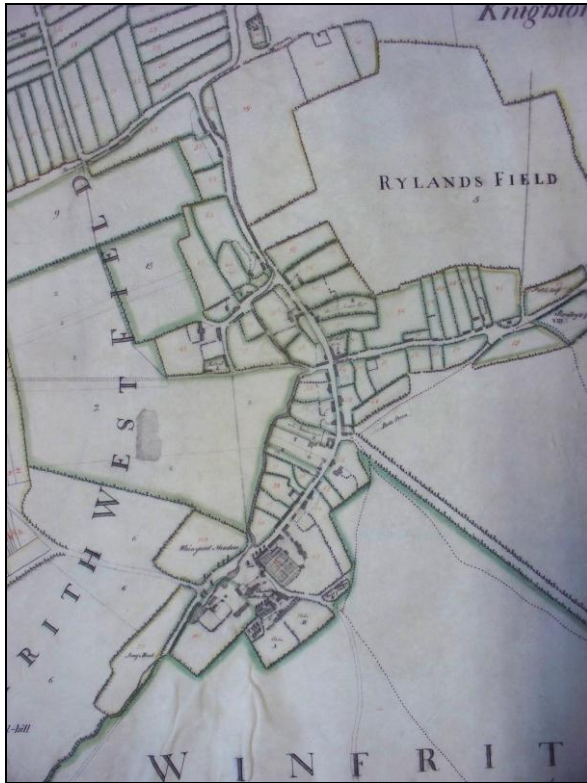
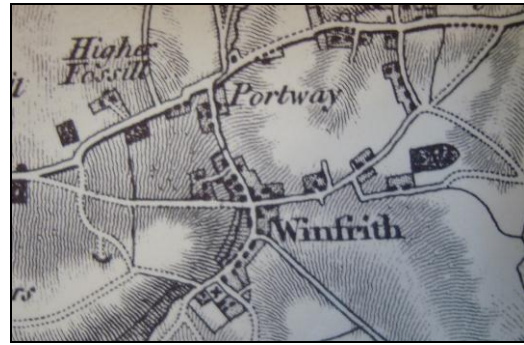
FIG. 3: *Historic maps. Left: 1770 Lulworth Estate map of Winfrith. Note the labeling of former open fields surrounding the village and presence of straight hedgerows which reflect recent 'inclosure'. Above: 1811 old series Ordnance Survey still showing the old route through the centre of the village.*

20. The 1770 Lulworth Estate map (see FIG. 3) provides a useful resource for the period, and shows The period saw establishment of a formal 'turnpike' road network through the county. These roads were privately financed, levying tolls from users. In 1768/9 the Dorchester and Wool Trust was established to link Wool and Dorchester by turnpike road (taking over the responsibility for this from the Wareham Trust). Through the upgrading and supplementation of existing roads this led to creation of what is now the A352. This bypassed Winfrith to the north, whereas the old route to Dorchester had previously run through the village via East Kinington and School Lane, forming a crossroads clearly seen in the 1811 map (FIG. 3). The route out of the village west remains a footpath and farm track.

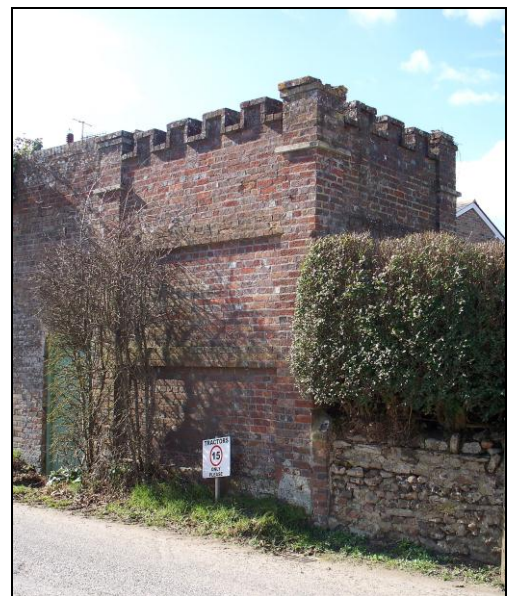
FIG. 4: *Gatehouse at Winfrith House.*

22. A number of eighteenth century tombstones survive in the graveyard of the parish church (see FIG. 10), reflecting growth in popularity of erecting monuments at this time. The most significant building constructed during the period was Winfrith House, which is thought to have replaced an earlier building on the site. The fine frontage, which is similar in appearance and date to that applied to the Manor, is largely hidden by an unusually high wall. This has clearly been raised on a number of occasions since its original construction, such that it now swamps the small gatehouse which stands at the northern end of the street frontage (see FIG. 4).

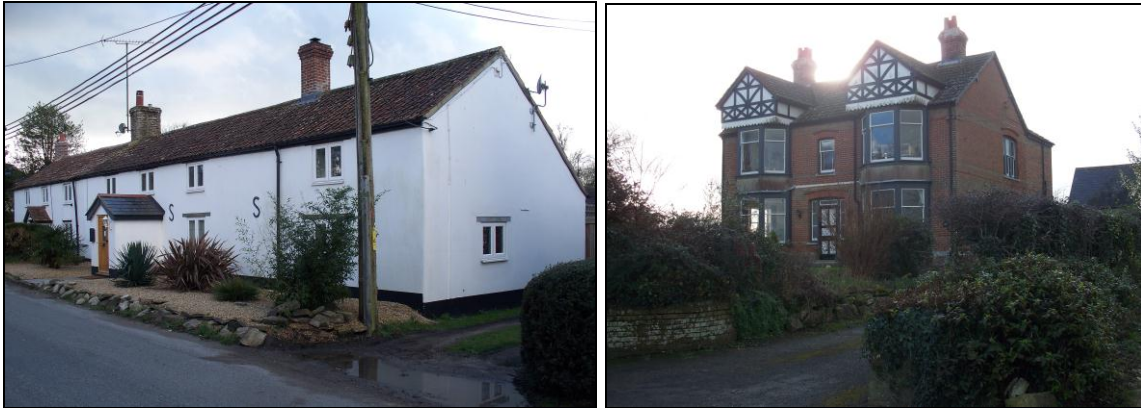
FIG. 5: *Nineteenth century development. Left: strongly linear form of Nos. 9/10. Right: Cleve House, a large villa of type more familiar in urban contexts and somewhat incongruous within the rural context.*

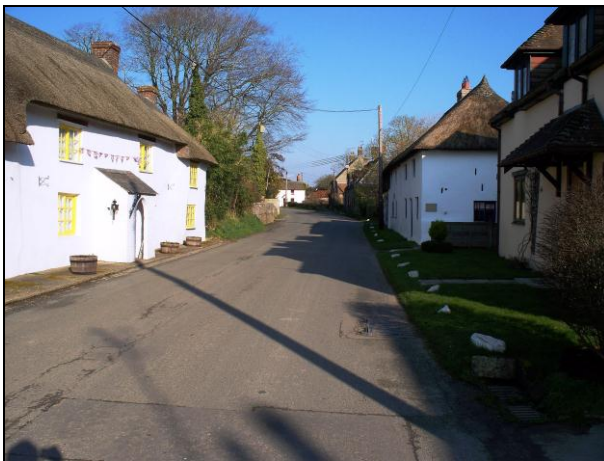
FIG. 6: *View up High Street to a point of intersection with Winfrith Drove. Properties are positioned either directly on the frontage, behind a verge of variable width or boundary walls.*

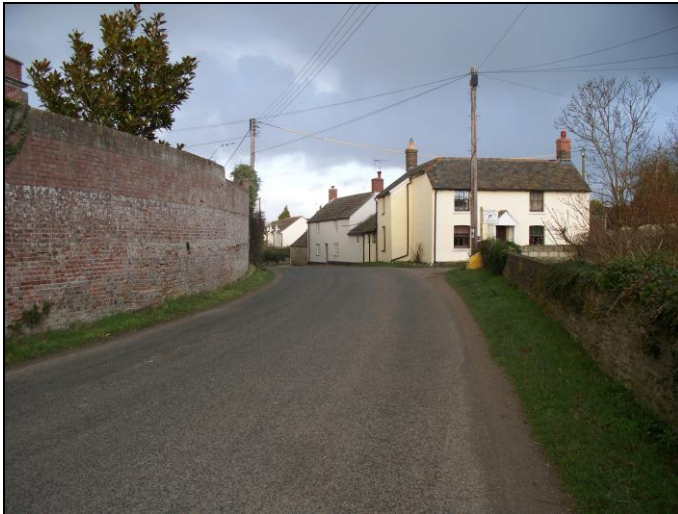
FIG. 7: *A view up High Street. The towering wall of Winfrith House focusses attention straight ahead as the road bends. Forge Cottage here plays an important role in 'closing' the view and turning a corner, forming an interesting grouping with Sunbeam Cottage.*

Cottage FIG. 7). The parish church and 'Manor House' have particular picturesque quality, complemented by their relationship to open space. Prior to heightening of its boundary wall, attractive views of Winfrith House would also have been available from the street.

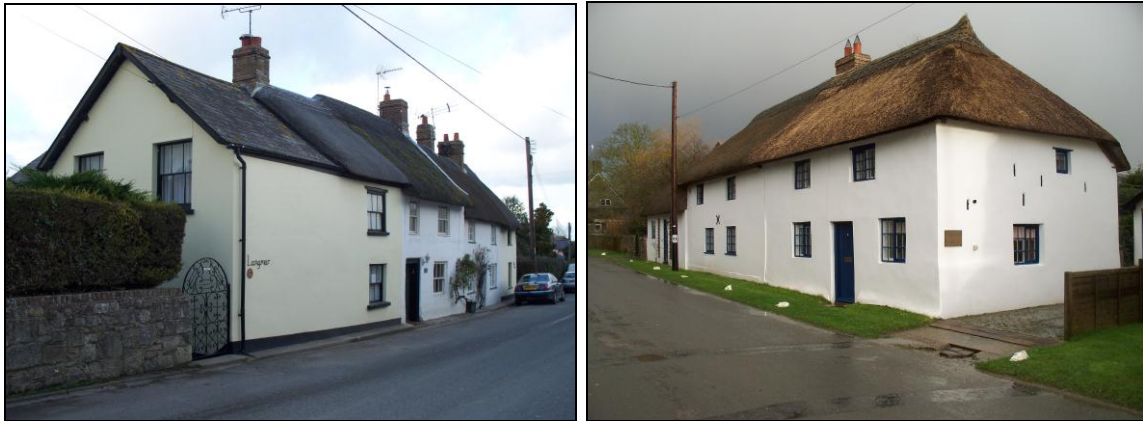
FIG. 8: Building forms along High Street. Left: Langmoor, Weston, Clovelly and Rose Lawn, a staggered terrace of cottages. Right: Badger's Thatch, Nos. 25.

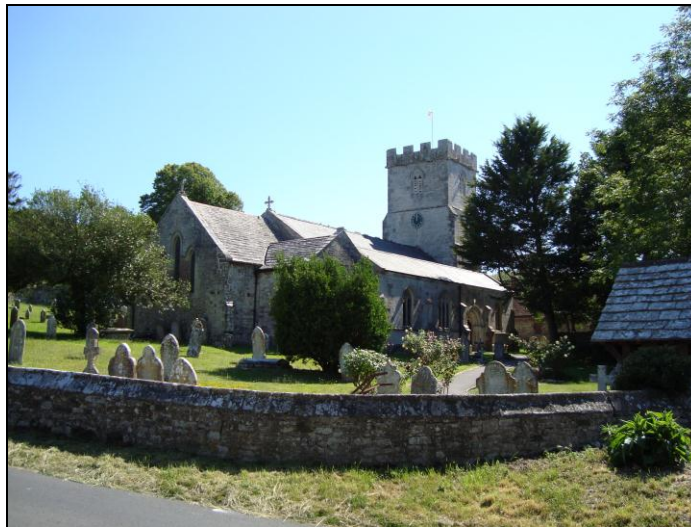
FIG. 9: *St. Christopher's – the parish church with graveyard.*

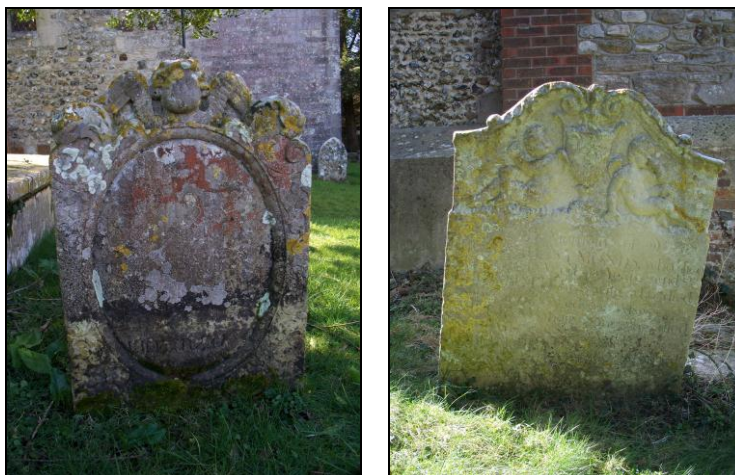
FIG. 10: Headstones. *Top left: tombstone with angel and scrolling. Top right: tombstone with cherubs (listed). Bottom left: tombstone with cherub and trumpet (listed). Bottom right: tombstone with angel holding a skull (listed).*

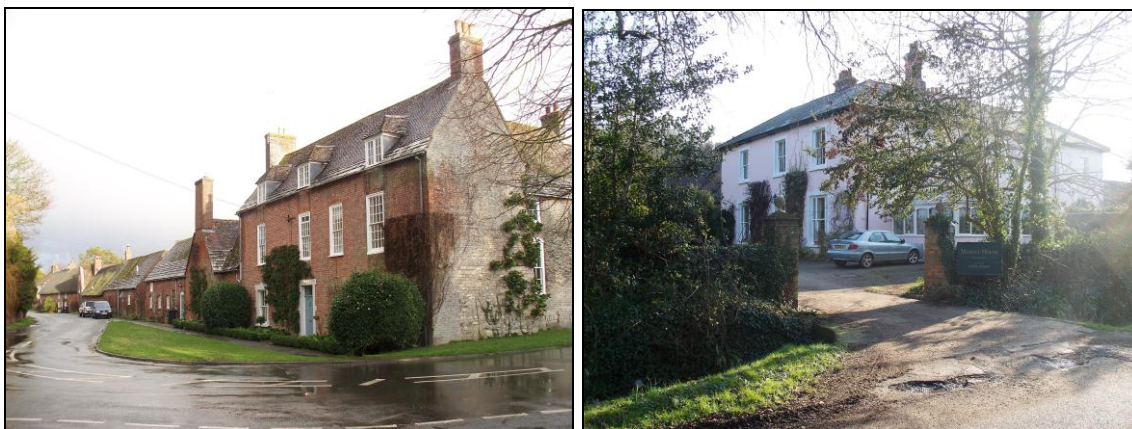
FIG. 11: *Formal architectural style. Left: The Manor House (formerly Winfrith Fields Farm). One of two fine Georgian façades visible within the conservation area. Right: Marley House has seventeenth century elements, though presents a formal early/mid nineteenth century appearance.*

42. Fine Georgian facades occur at Winfrith House (FIG. 11 below) and the Manor House, and a third of similar style is largely hidden at Winfrith Court. Other formal facades exist at Marley House (FIG. 11 below), and at smaller and simpler scale at Greenfields, Cheriton House, Brook House and East Fossil Farm. True to the general rule, 'vernacular' development (or that constructed according to local tradition as opposed to formal style) is far less consistent in appearance and composition, making use of a wide range of materials. Cleve House (see FIG. 3) is a large villa of pattern book style, of a type more familiar within urban contexts. Wincott similarly represents a suburban form of the inter-war period. Both properties appear incongruous in the rural context. Modern development has adopted a similarly standardised and repetitious format.

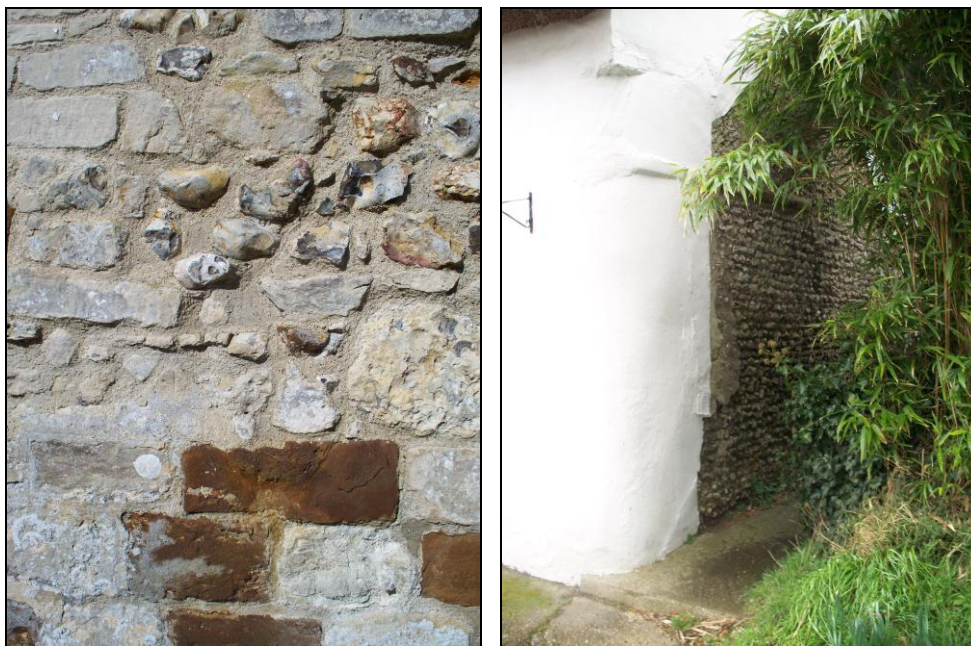
FIG. 12: *Building stone. Left: a mixture of heathstone, limestone and flint used in the thirteenth century chancel of St. Christopher's. Right: Exposed gable wall of the Malthouse, which shows regularly coursed flint, though the frontage is rendered.*

44. The range of masonry types used within the conservation area is best summed up in the construction of the thirteenth century chancel of St. Christopher's, which contains a mixture of flint, heathstone and limestone (see FIG. 12 below).

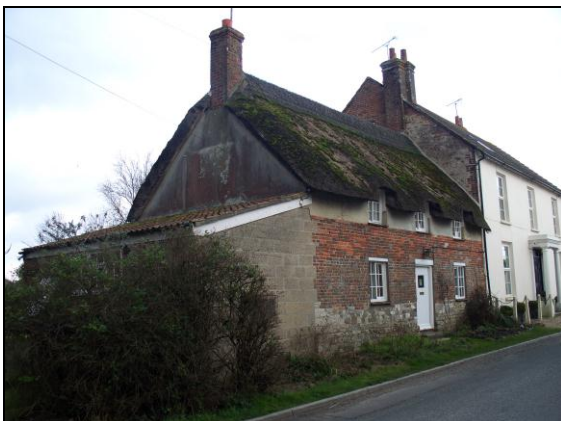
FIG. 13: *Little Rhylcombe Farmhouse. The facade contains a mix of materials, showing evidence of a complex evolution: stone plinth of limestone and heathstone, with brick walls of two phases raised in cob, topped by a thatched roof. Though unsympathetic in design and construction, the concrete block extension with double roman tiled roof further adds to the mix.*

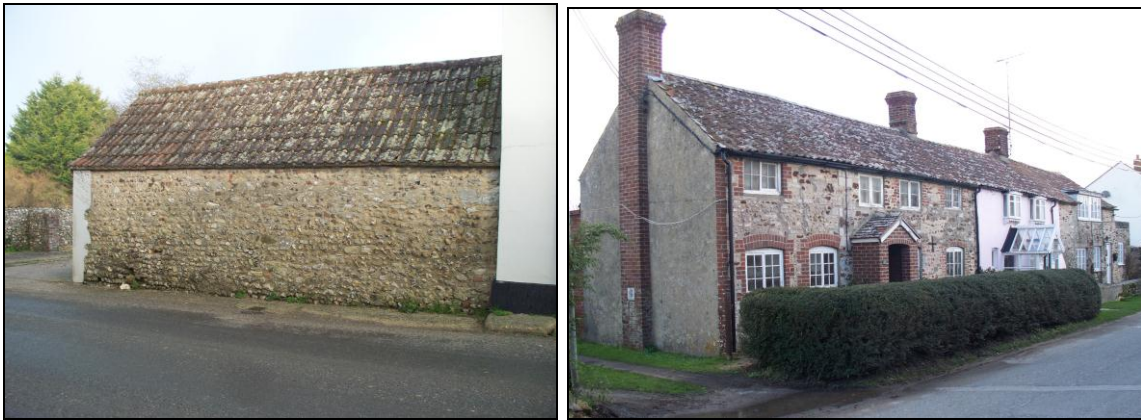
FIG. 14: Tiled roofs. Left: double Roman tiles used at Sunbeam Cottage where photographic evidence suggests they may have replaced thatch. Right: pantiles used on the roofs of Nos. 6-8 High Street. Note, in both examples walls here appear to have been partially stripped of the original protective render finish exposing poor quality rubble.

55. Most noticeable is the use of large format double Roman and pantiles. Historically these were chiefly manufactured in Bridgewater, Somerset, and use is unlikely to pre-date the second half of the nineteenth century when rail transport assisted distribution. As elsewhere in the District, double Roman tiles find sparing use on outbuildings such as at Sunbeam Cottage and Brook House (see FIG. 14 below). Pantiles are seen on outbuildings to the rear of Manor, and topping adjacent boundary walls, and are also used in the roofing of Nos. 6-8 and 9-10 High Street – two essentially similar terraces (see FIG. 14 below). As historic use of pantiles was rare in the District, the frequency of their use in Winfrith is unusual.

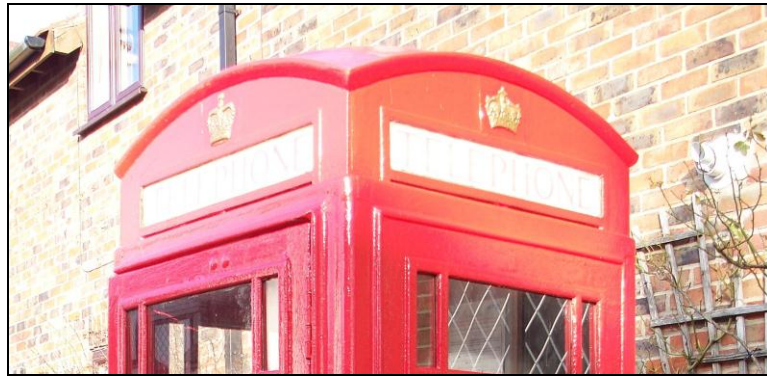
FIG. 15: *K6 call box. The front face shown above carries a coronation crown (used after 1955), whereas that on the right face carries a jubilee crown (used 1936 -1955 in the UK, and overseas).*

- *K6 telephone box, High Street.* The kiosk dates from 1950s, and is unusual in that it carries a combination of coronation and earlier jubilee crowns (see FIG. 15 below).

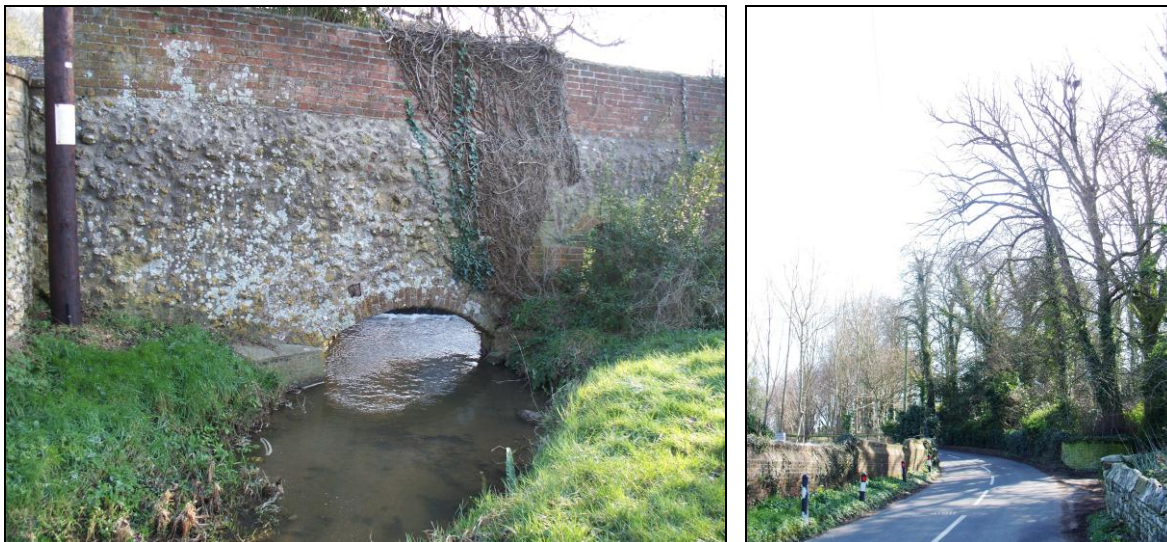
FIG. 16: *Habitats within the conservation area. Left: the River Win as it flows beneath a boundary wall adjacent to Marley House. Right: attractive groups of tall trees at Oat Hill which play host to a noisy rookery.*

61. Buildings and the many trees, hedges and garden spaces within the conservation area provide nesting, roosting and feeding opportunities for birds, bats and small mammals. A rookery is evident in the tall trees at Oat Hill (see FIG. 16 below), the distinct calls of the birds evoking a strongly rural feel. The River Win is particularly important habitat which stretches the length of the settlement. The habitat appears richest where the river meanders more or less naturally behind the High Street. The churchyard contains a good collection of lichens attached to tombstones, and these are otherwise present on the roofs of many houses.

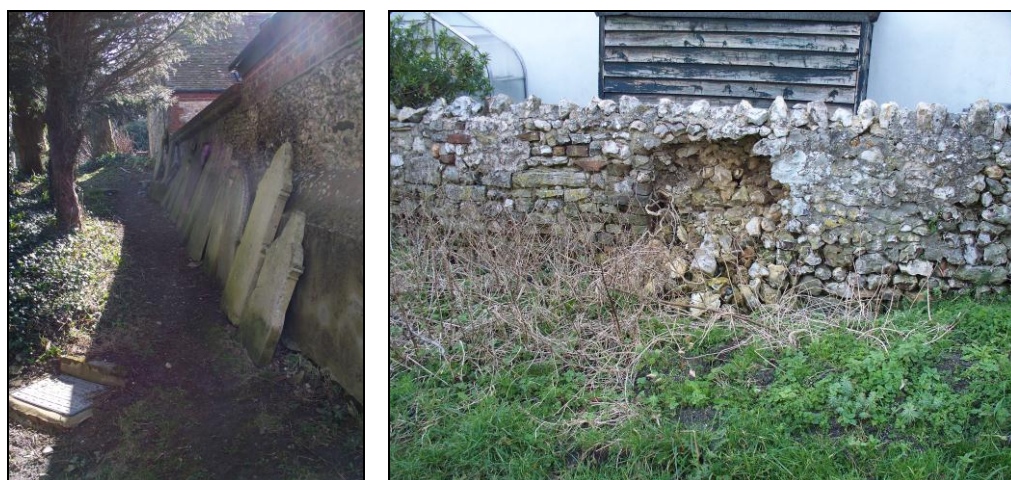
FIG. 17: *Damage and decay. Left: toppled or removed headstones propped against the churchyard wall. A number of these are of eighteenth century date. Right: Collapsing flint boundary wall adjacent to No. 1 The Orchard.*

64. Buildings within the conservation area appear generally well maintained from external inspection, however there are some signs of deterioration in the churchyard and boundary walls (see FIG. 17 below).

Management of vegetation: the treatment and careful removal of ivy from the walls of the churchyard and Manor House would prevent further damage to the masonry. Proper repair of damage already caused, and that sustained in the process of removal, would be essential.
