Appendix B

Groundsure report

STREET RECORD, BALACLAVA ROAD, PORTLAND, DT5 1PA

Zetica (2020) UXO Desk Study & Risk Assessment

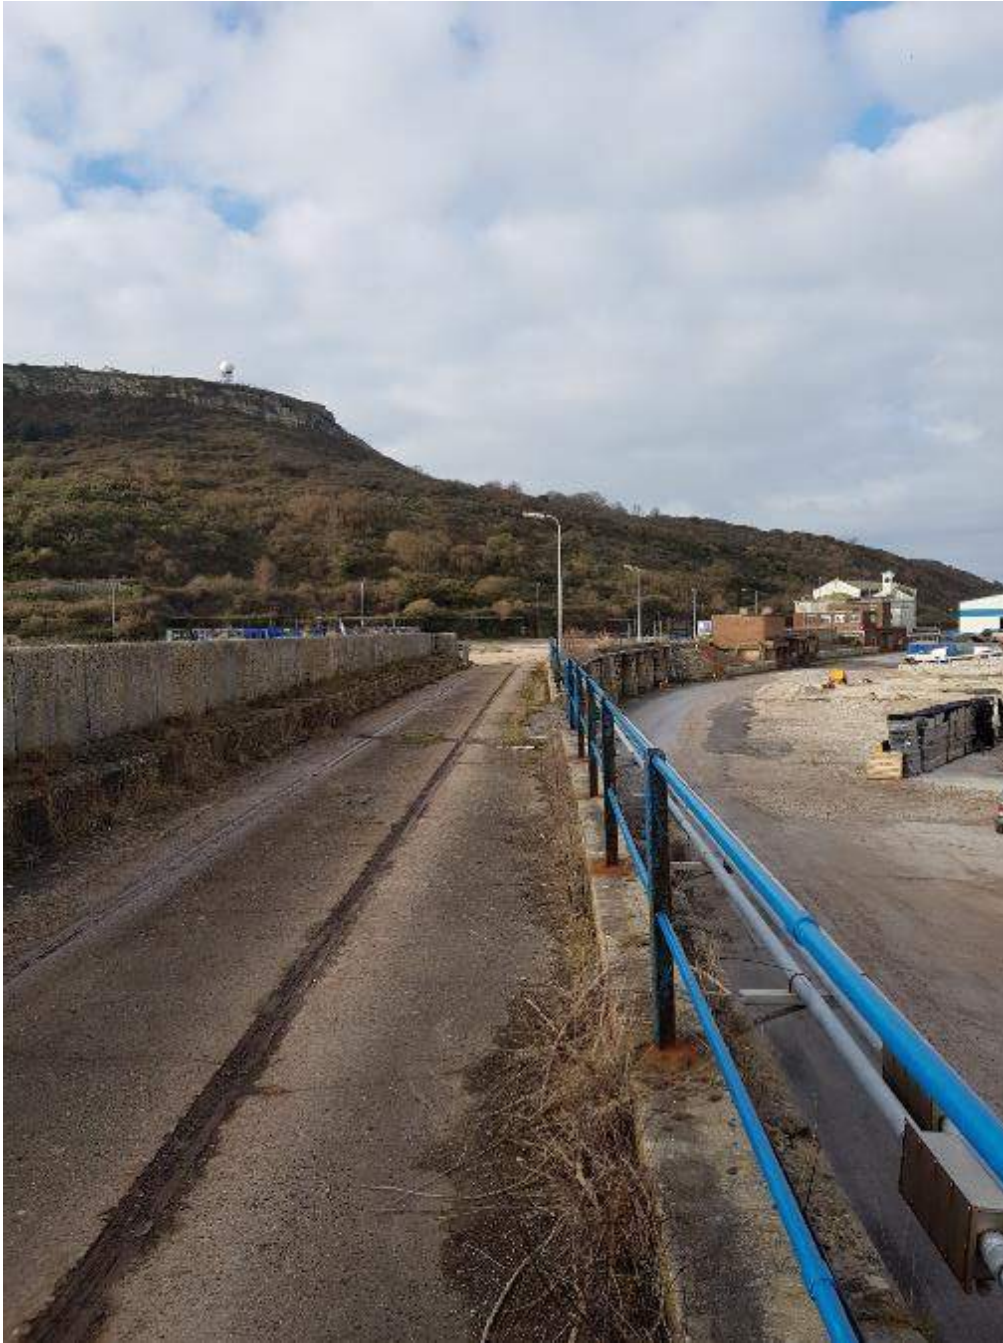
Photograph 9: Retaining structure along northern site boundary
