Objection to the Planning application of Powerfuel Limited, to build a waste Incinerator in Portland Port and next to our existing Bunker facilities.

Impact Study Report

Portland Bunkers UK Ltd.

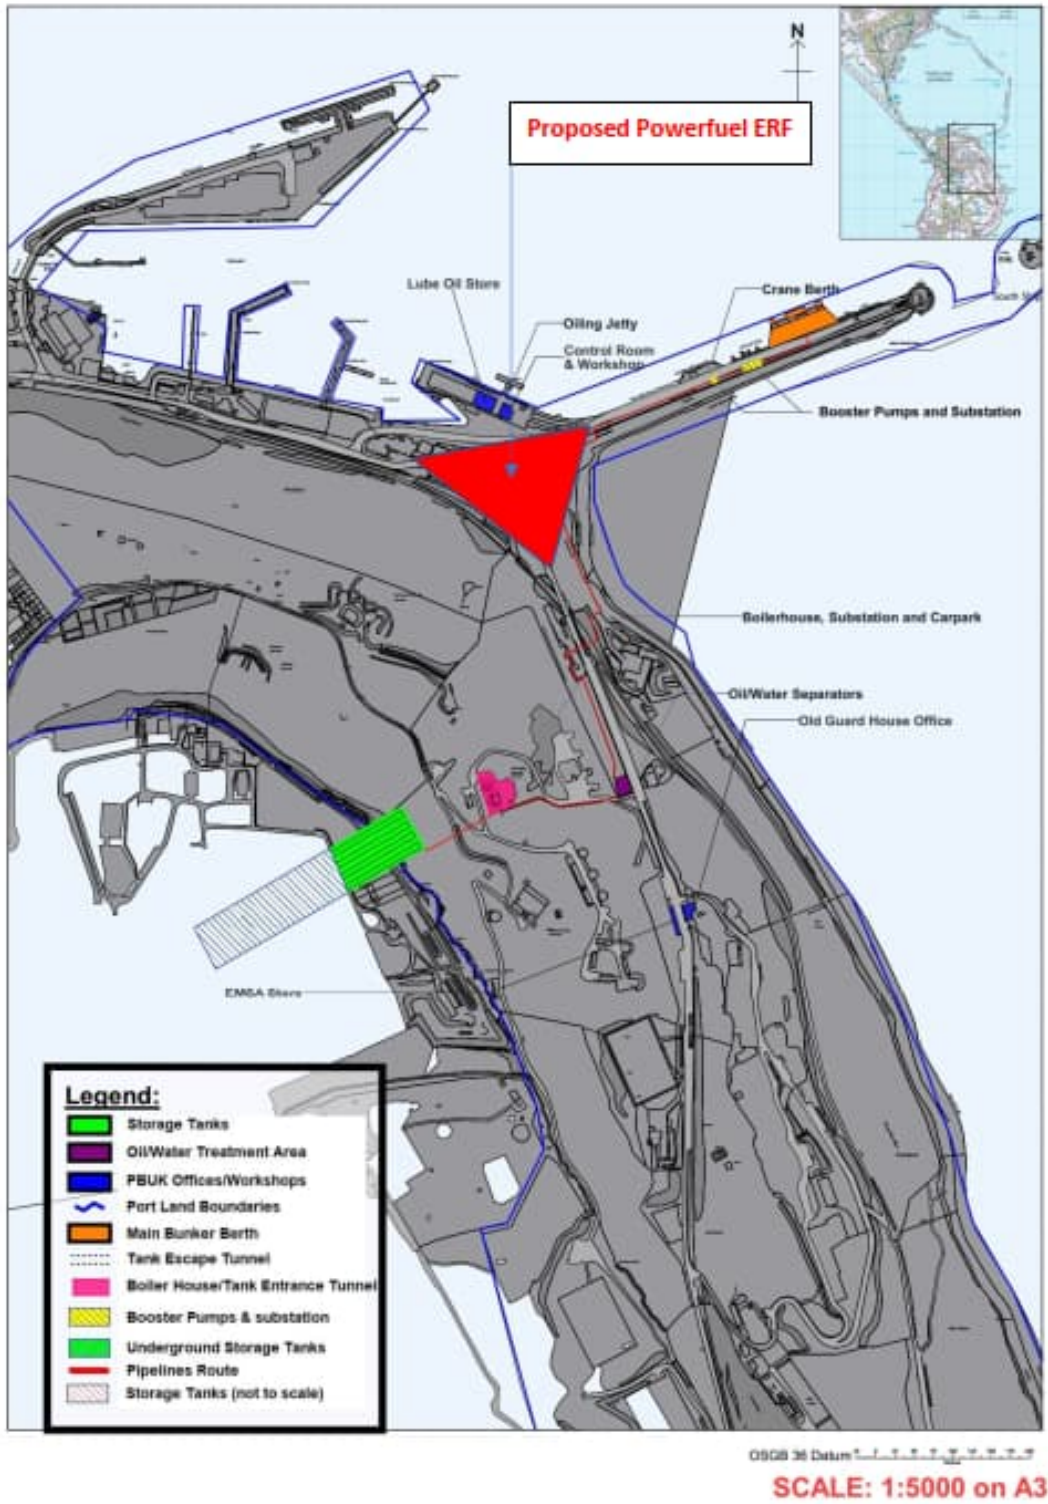
Figure 1- Location and Layout of the Portland Bunker Facilities and Proposed Power Fuel ERF

Criteria	Detail
	number of relatively level terraces that mark the location of former development areas. The site situation and location of proposed Powerfuel ERF is shown in Figure 1.
Site Ownership	Portland Port Ltd, Leased to Portland Bunkers UK
Current Site Use	Bunkering services (Shipping/Marine fuel loading and unloading) Marine Fuel Storage
Site Access	The site is accessible from mainland by the A354 from Dorchester. The harbour lies approximately 20 nautical miles north from the main English Channel shipping lanes and is in close proximity to other European ports.
Site Boundaries	The facility is located at Portland Port and as such is surrounded by Port facilities and other lease holders. It is bordered to the north by Portland Harbour itself. The east boundary is formed by Incline Road. The fuel tanks lie directly under the HMP Verne.

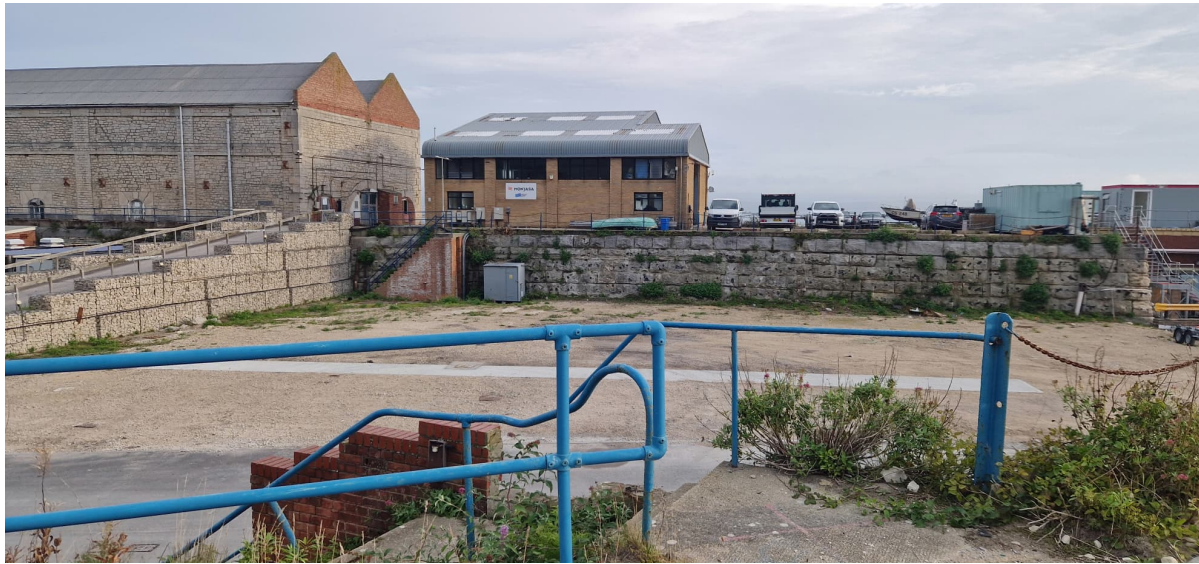
Figure 2– PBUK control room, lube oil store, and workshop

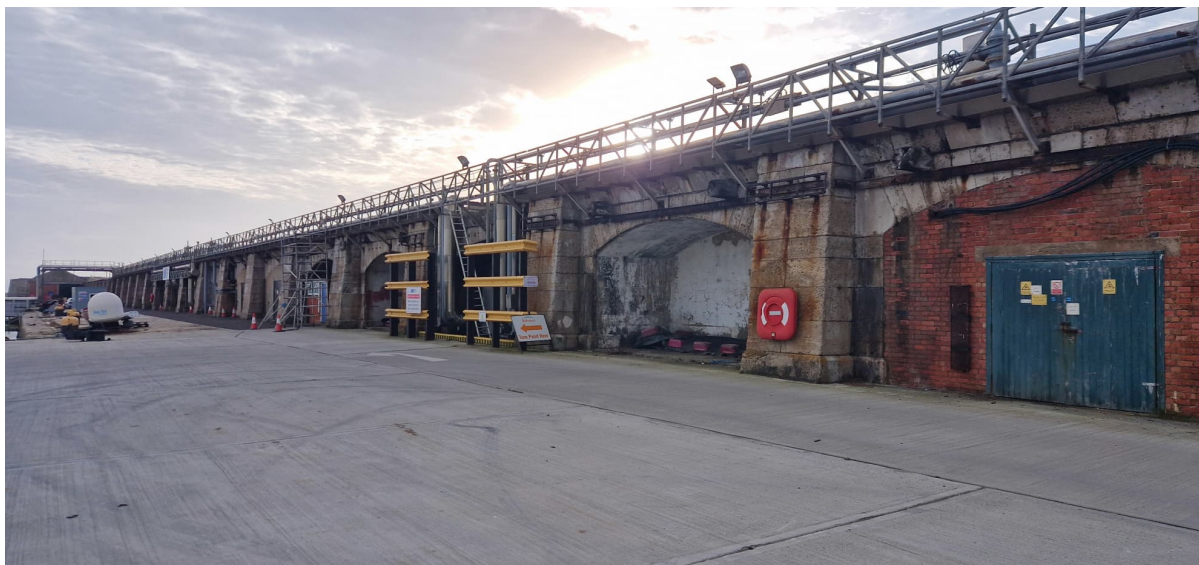
Figure 3 – PBUK fuel bunkering lines and hot oil lines along the jetty.

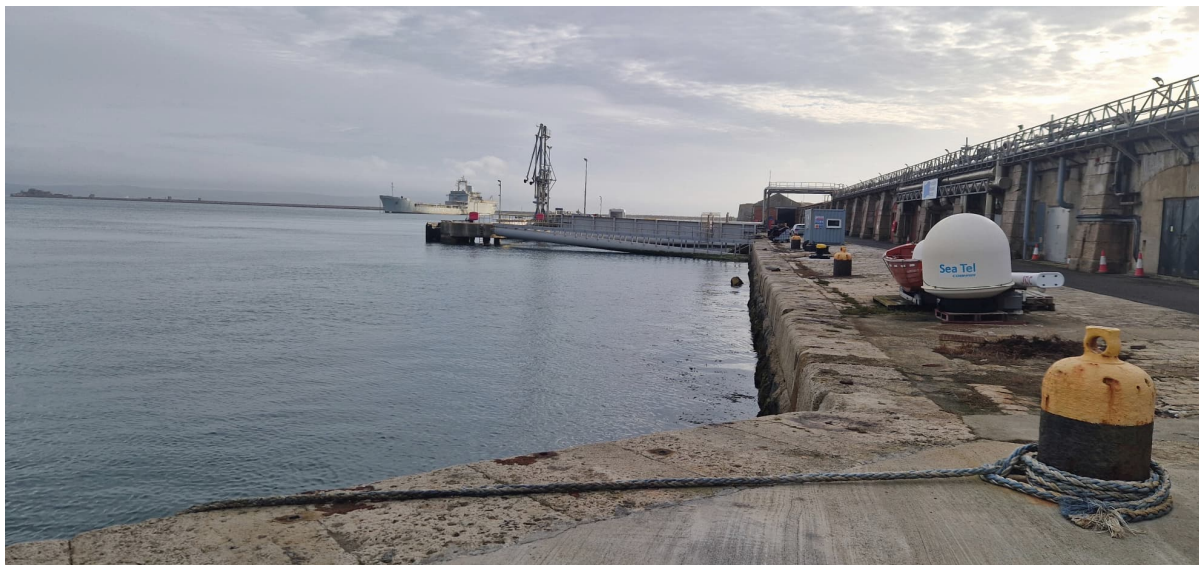
Figure 4 – PBUK fuel bunkering berth

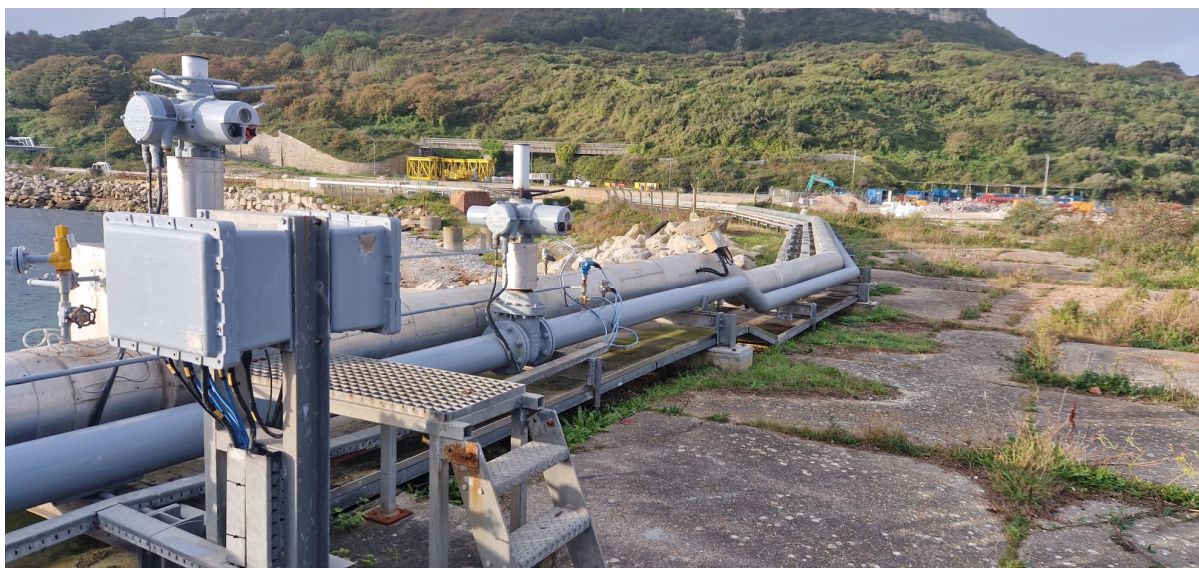
Figure 5 – PBUK fuel bunkering lines, hot oil lines and control next to Balaclava Bay.

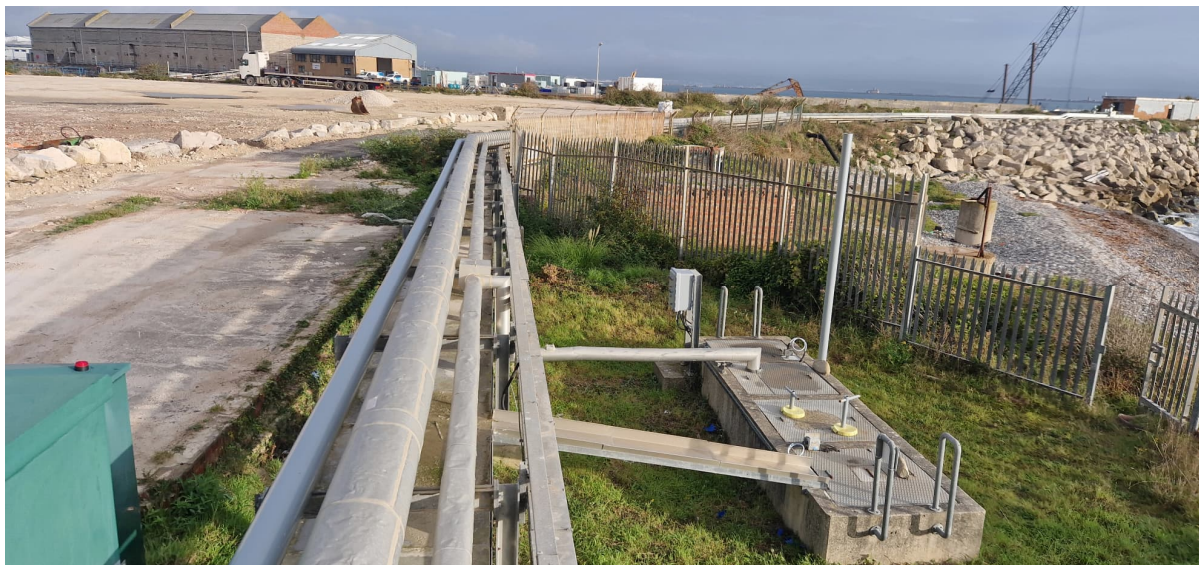
Figure 6 – PBUK fuel bunkering lines, hot oil lines, controls and sump next to Balaclava Road (PBUK control room, lube oil store and workshop in the background).

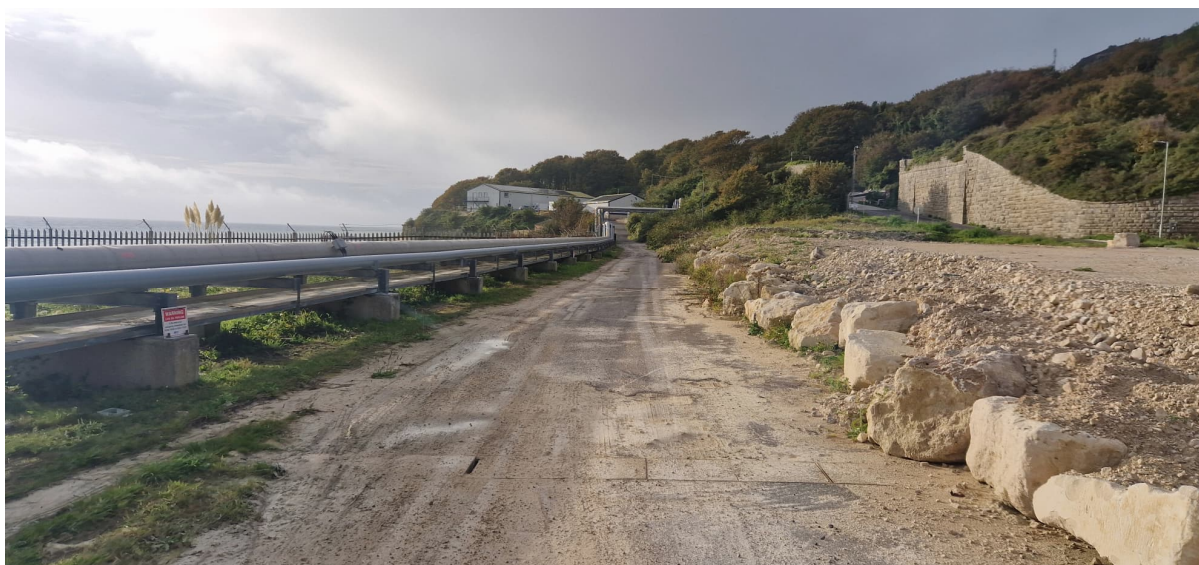
Figure 7 – PBUK fuel bunkering lines and hot oil lines next to Balaclava Road.

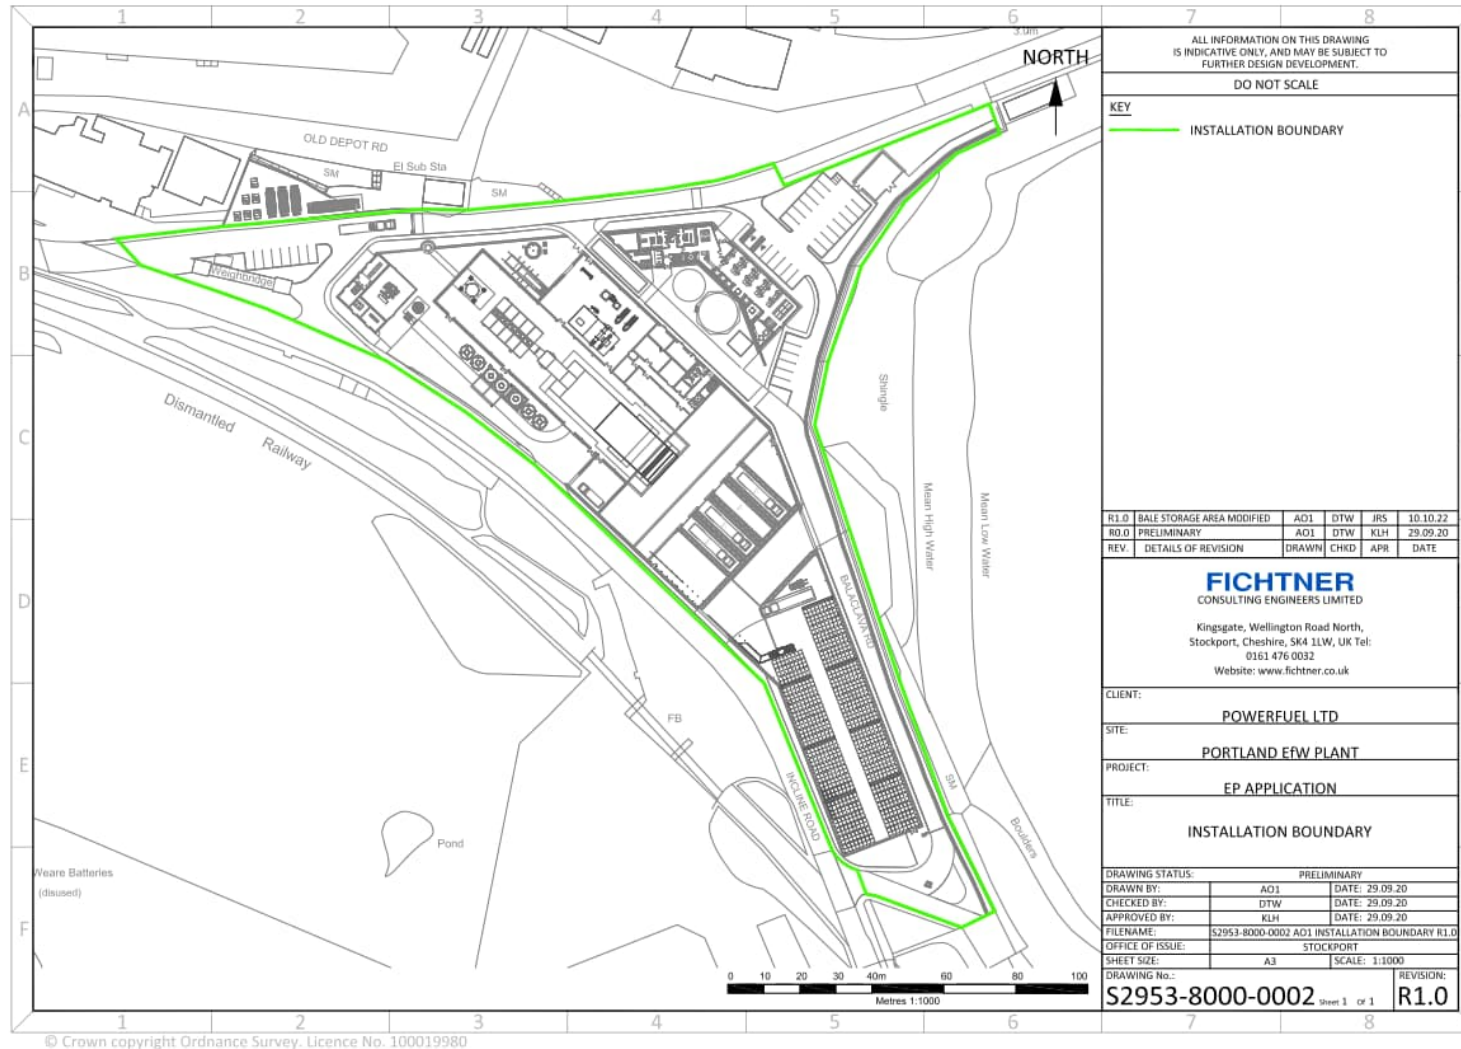
Figure A1 – Powerfuel Ltd. Proposed ERF Layout

Powerfuel Portland Ltd. (Powerfuel) have proposed the installation of an Energy Recovery Facility (ERF) that will burn refuse adjacent to the PBUK facilities (see: Powerfuel Proposed ERF Layout within Appendix 1). PBUK want to understand the impact of the ERF development on their COMAH regulated facilities including health and wellbeing of their workforce.
