Portland
energy recovery
facility

Powerfuel Portland Ltd
Portland Energy Recovery Facility
Preliminary Slope Stability
Assessment

Issue 3 | 29 July 2021

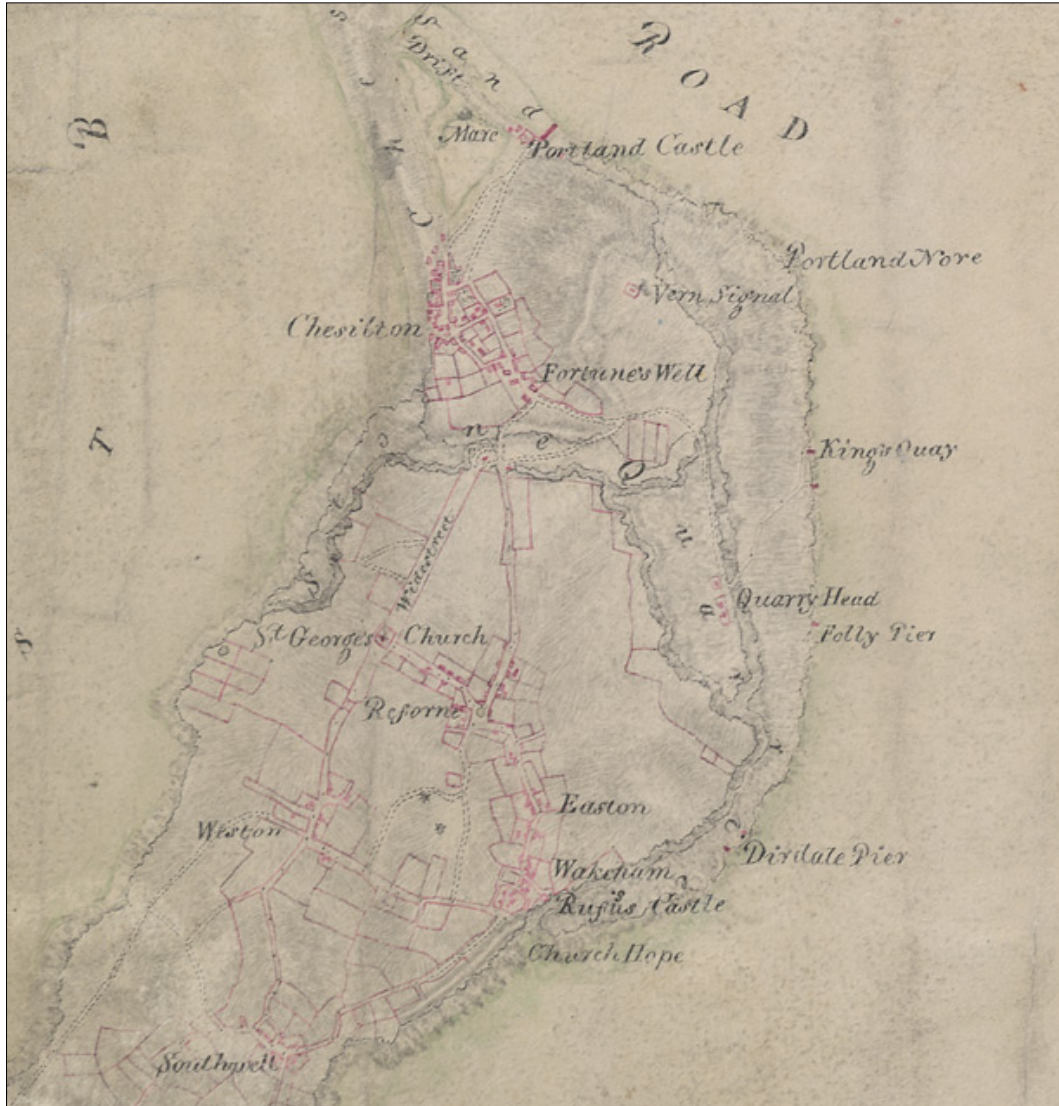
Figure 2: 1805 OS Map (British Library, supplied under the Open Government License v1.0)

The 1805 OS map (Figure 2) indicates the site prior to development of the harbour and shows the coastline to be approximately in the position of the current steep slope above the site.

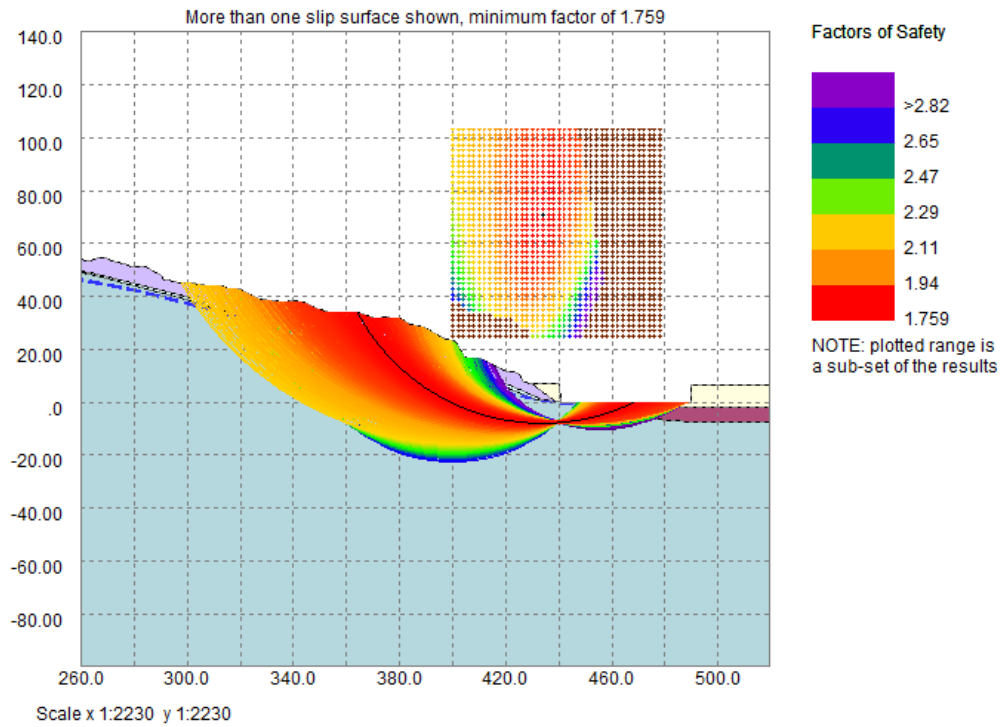
Figure 11: Slope analysis for proposed excavation

The results of the analysis are shown in Figure 11.

It can be seen that the slip circles must go much deeper within the undisturbed Kimmeridge Clay (to pass beneath the embedded retaining wall) and the factor of safety is significantly higher than expected for shallow slips on the slope above the site.

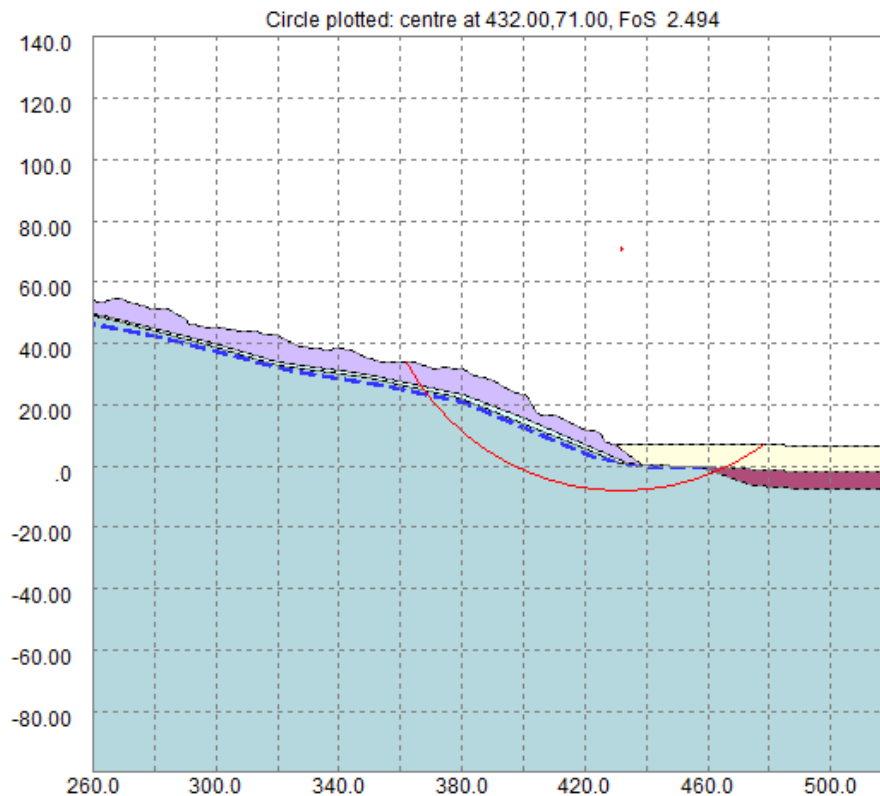
Figure 12: Current situation showing minimum slip circle geometry

Using the minimum slip circle geometry in the above analysis, a check was made against the current situation, as shown in Figure 12.

This suggests that the removal of weight at the toe of the slope would have a significant effect on factor of safety for this slip circle (from FOS 2.5 to FOS 1.8).
